Appendix C – WPCF Concrete Inspection Photograph Log

Project: East Providence, RI WPCF - Structural Assessment and Rehabilitation Design
Date: September 8th, 2021

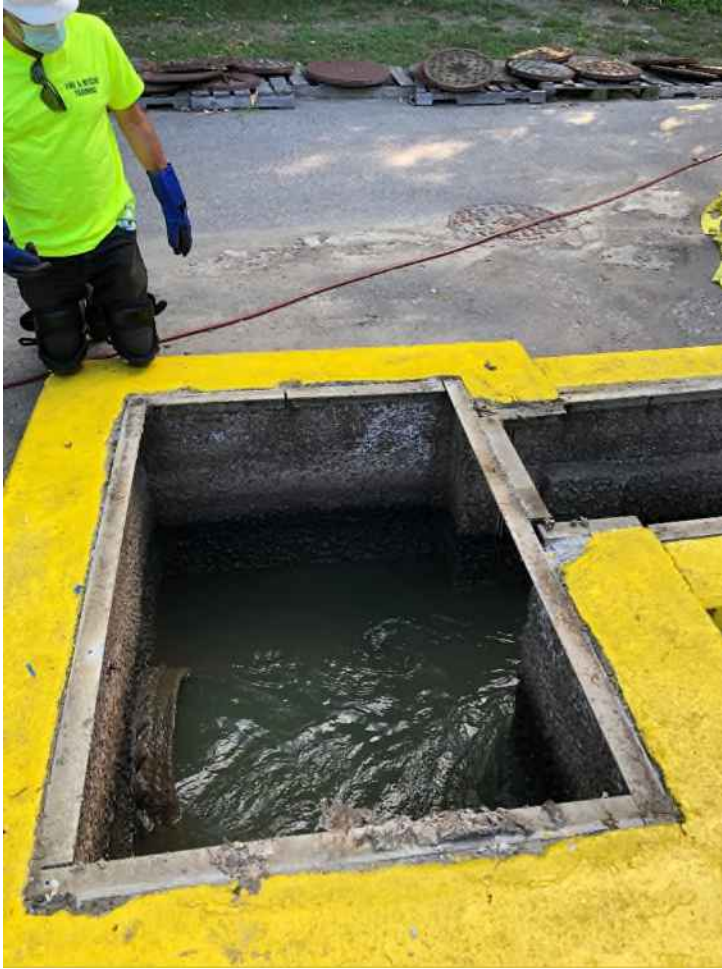
Photo No.: 1

**Description: East Wall
General Condition**

**Location: Headworks
Building**

**Area: Exterior Influent
Channel**

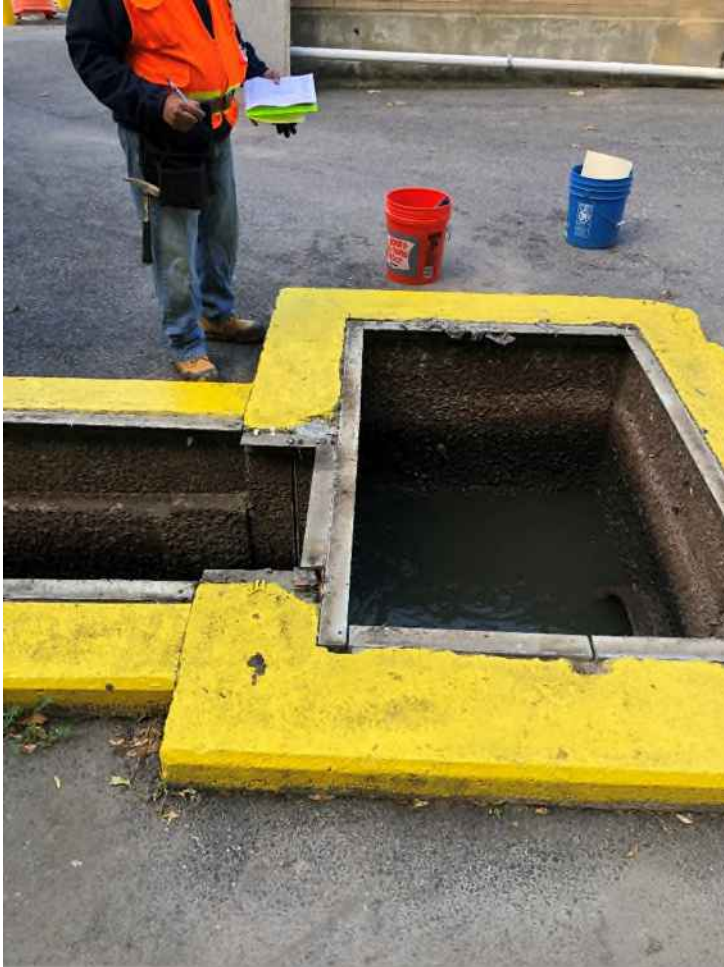
Photo No.: 2

**Description: West
Wall General
Condition**

**Location: Headworks
Building**

**Area: Influent
Channel**

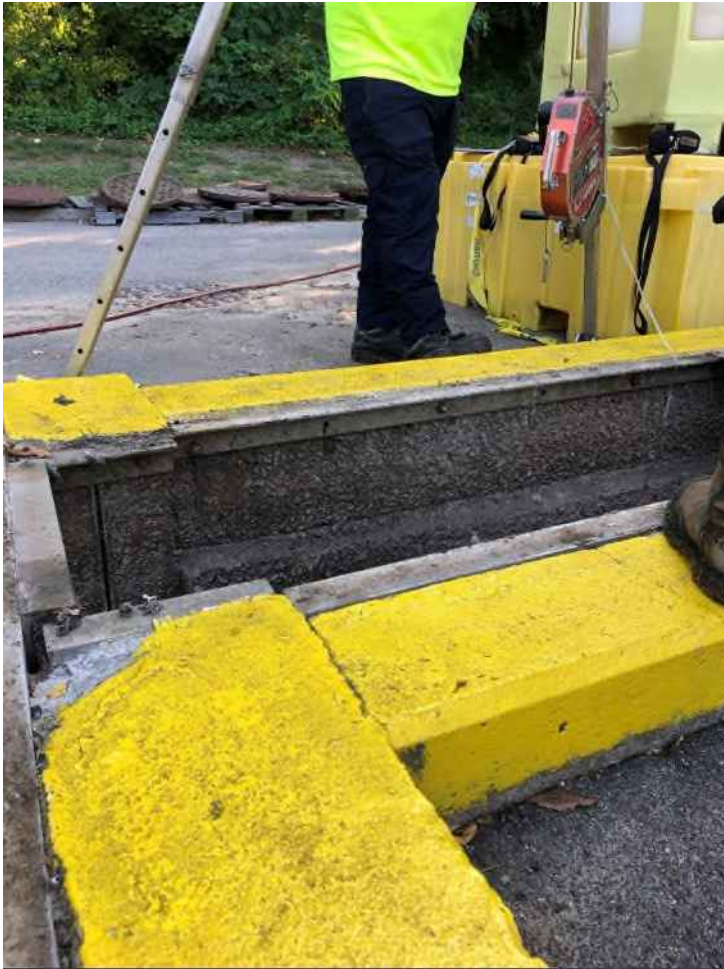
Photo No.: 3

**Description: Exterior
Influent Grating
Supports, East Wall**

**Location: Headworks
Building**

**Area: Influent
Channel**

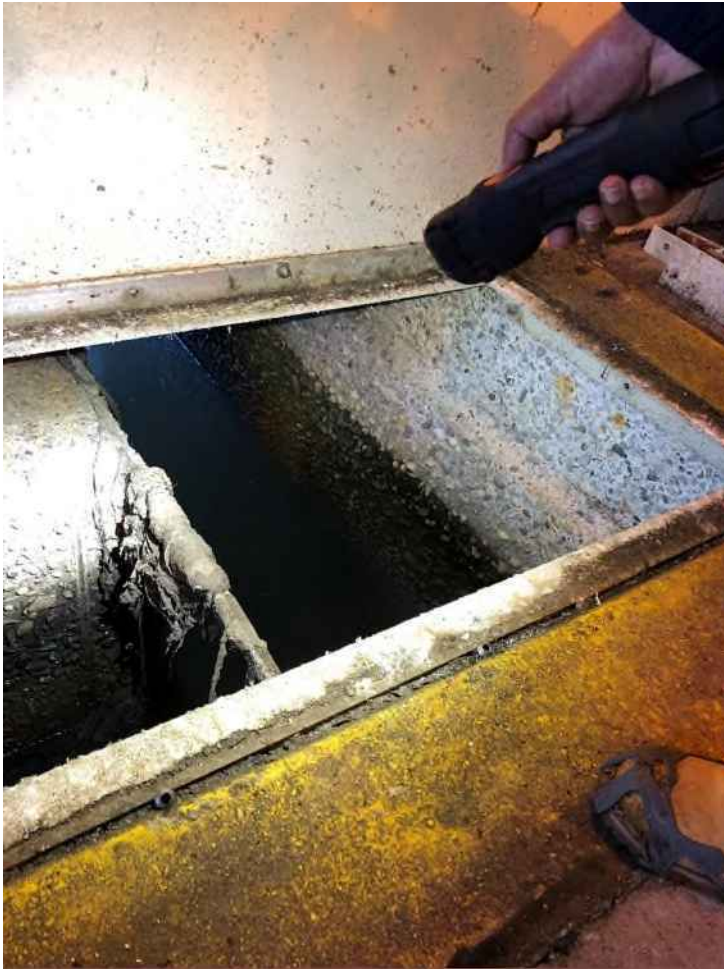
Photo No.: 4

**Description: East Wall
Exposed Aggregate**

**Location: Headworks
Building**

**Area: Influent
Channel**

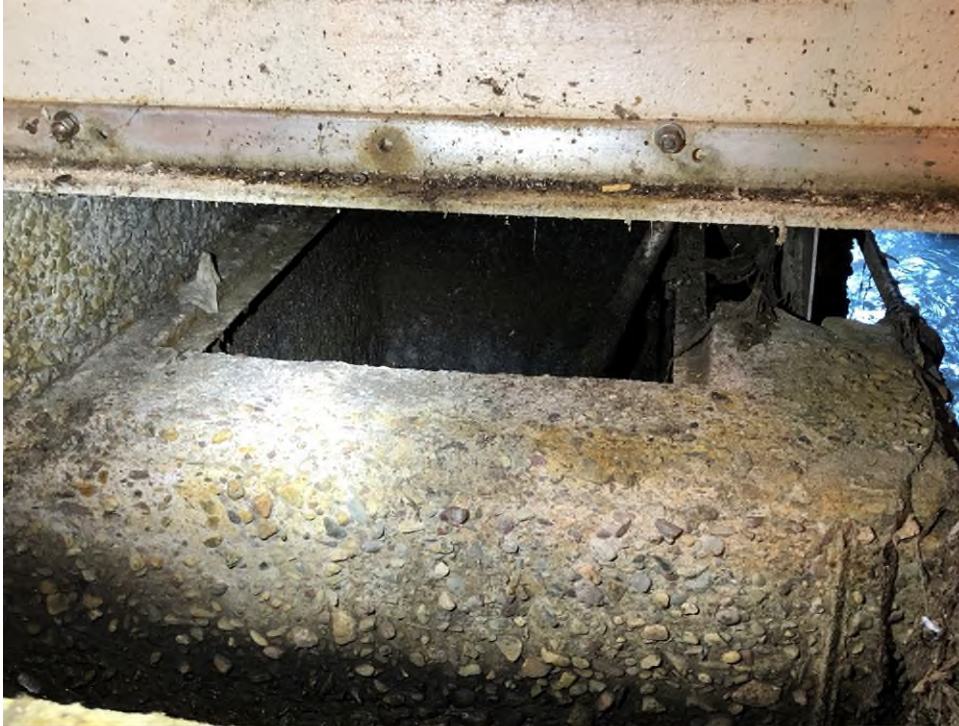
Photo No.: 5

**Description: Dividing
Wall Exposed
Aggregate**

**Location: Headworks
Building**

**Area: Influent
Channel**

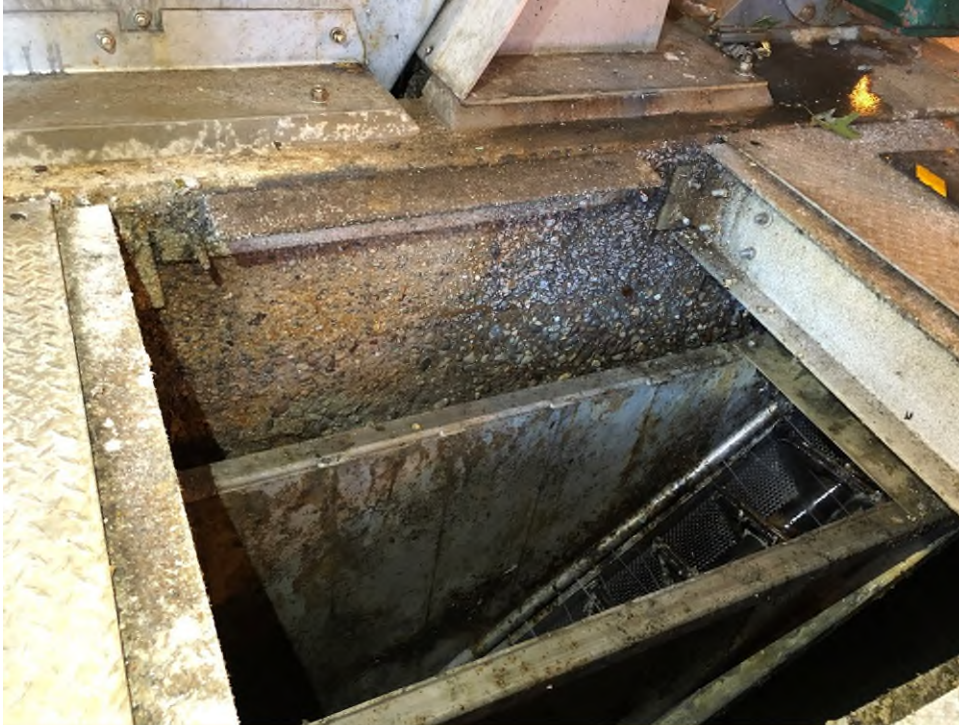
Photo No.: 6

**Description: East Wall
Exposed Aggregate**

**Location: Headworks
Building**

**Area: Screw
Conveyor**

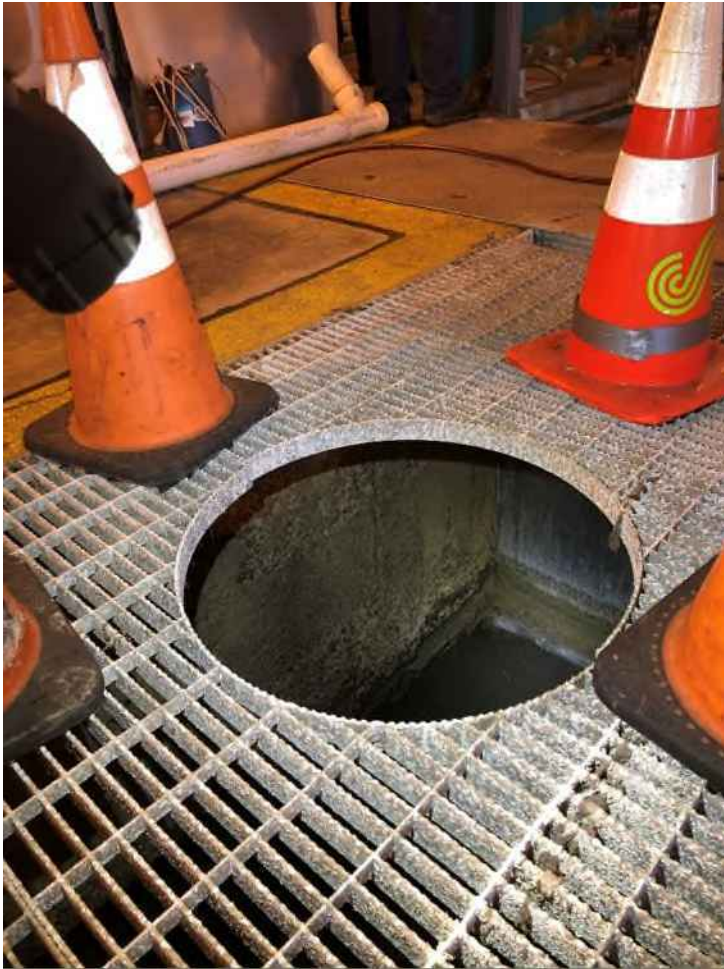
Photo No.: 7

**Description: East Wall
Exposed Aggregate
and Spalling**

**Location: Headworks
Building**

**Area: Diversion
Channel**

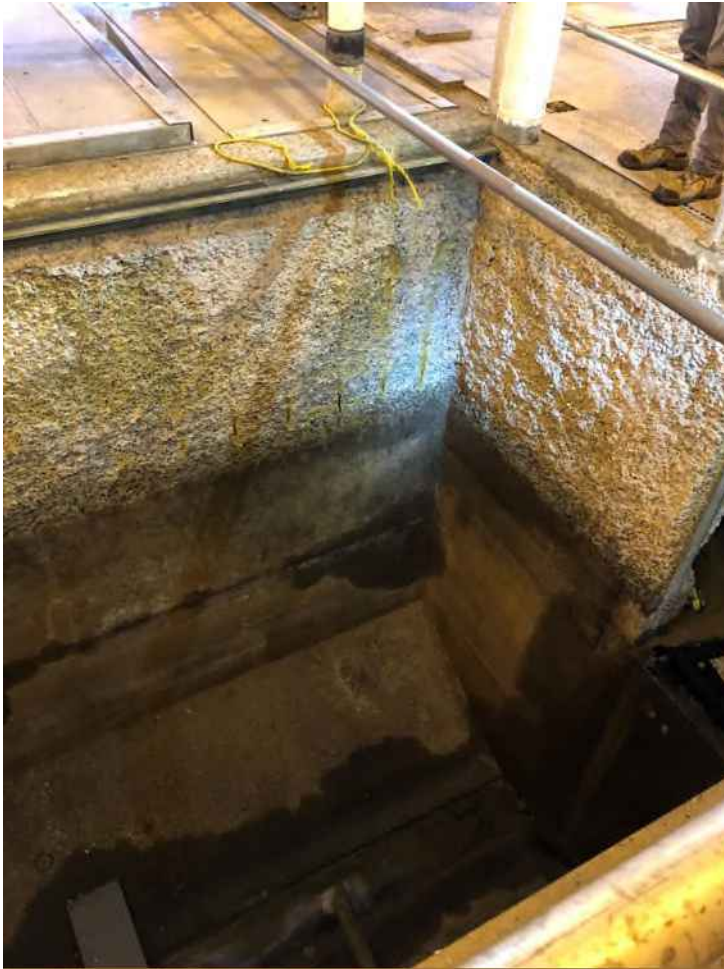
Photo No.: 8

**Description: North
and West Wall
General Condition
and Soft Concrete
From Grade**

**Location: Headworks
Building**

**Area: East Grit
Chamber**

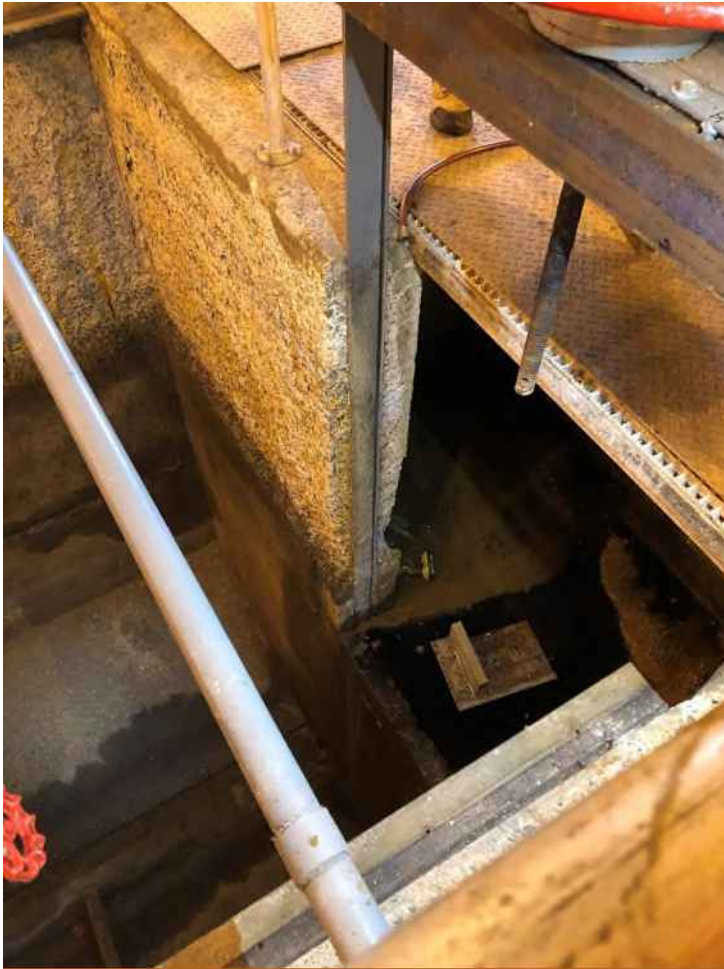
Photo No.: 9

**Description: North
Wall and Influent Gate
Opening. General
Condition and Soft
Concrete From Grade**

**Location: Headworks
Building**

**Area: East Grit
Chamber**

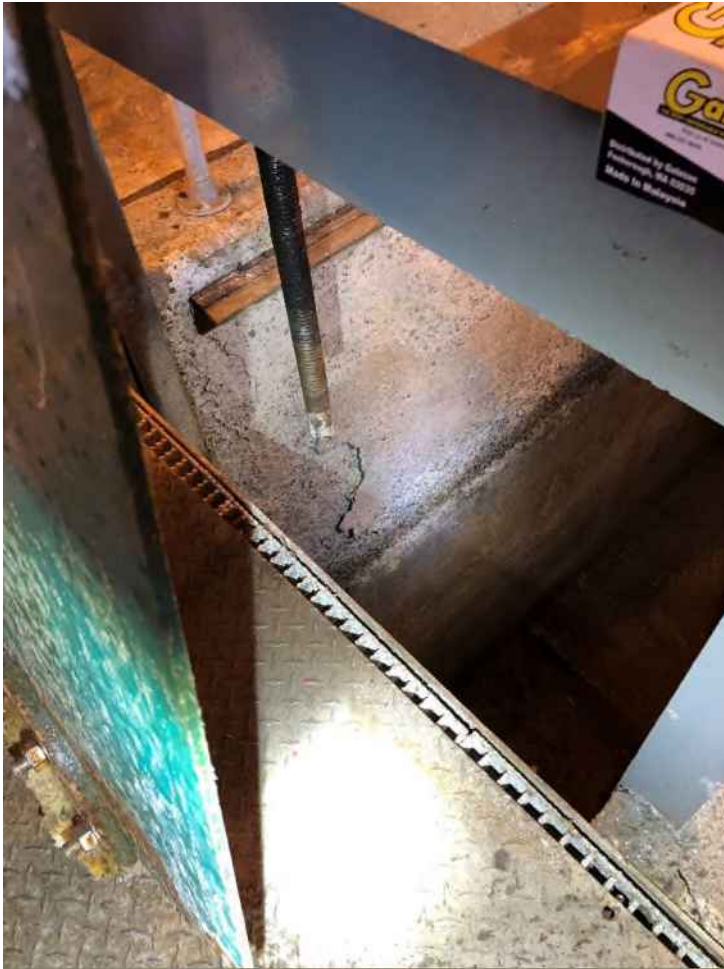
Photo No.: 10

**Description: East Wall
General Condition
and Hollow/Soft
Concrete From Grade**

**Location: Headworks
Building**

**Area: East Grit
Chamber**

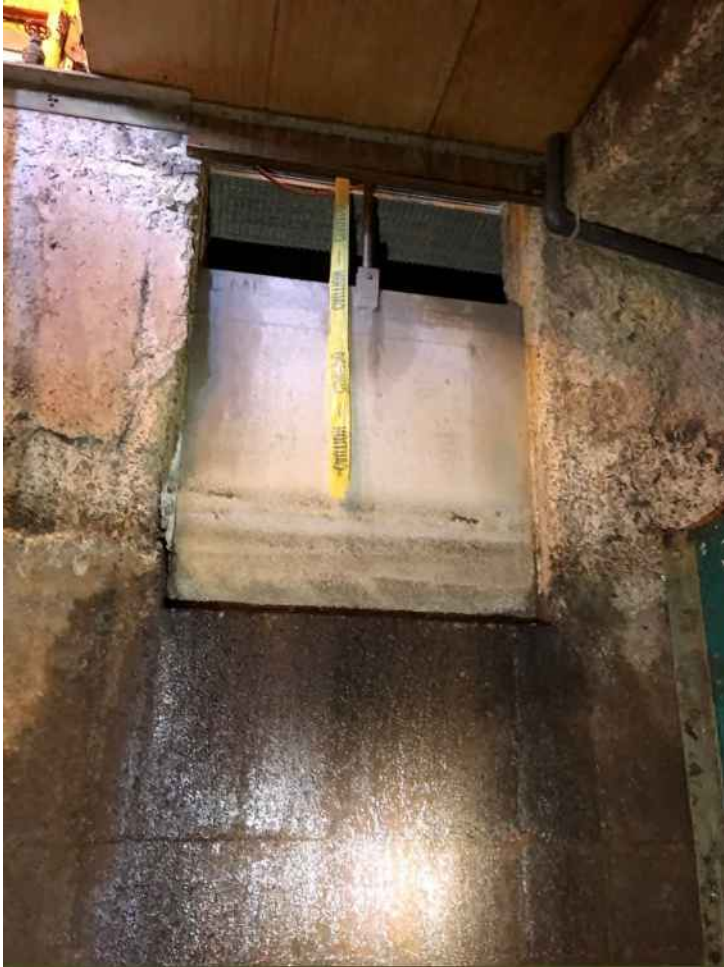
Photo No.: 11

**Description: Effluent
Gate, Adjacent
Concrete Spalling and
Soft Concrete**

**Location: Headworks
Building**

**Area: East Grit
Chamber, Effluent
Gate**

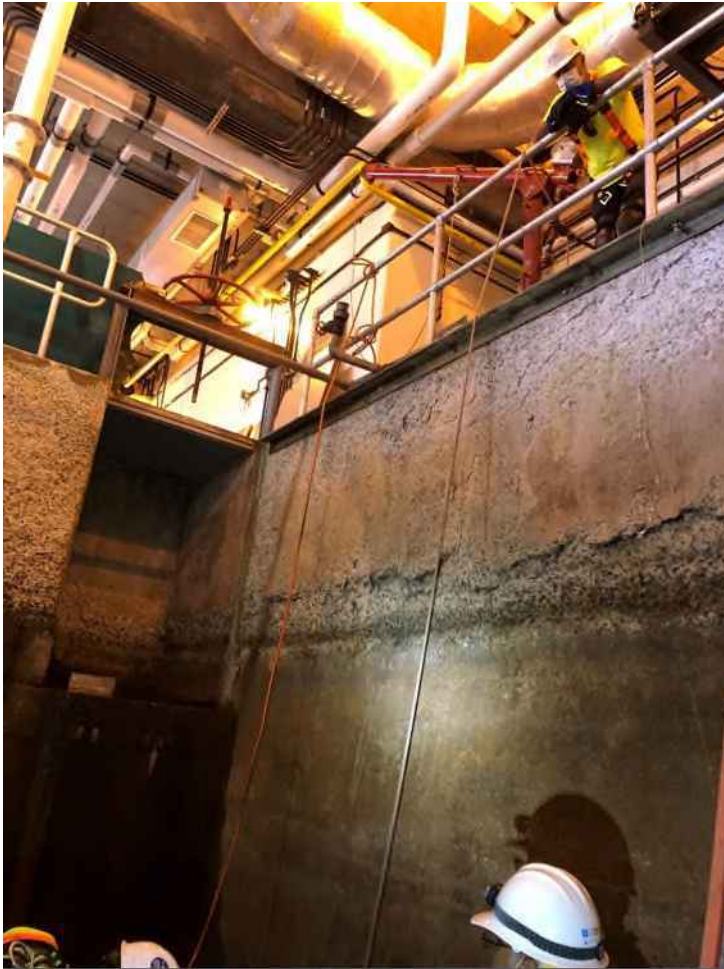
Photo No.: 12

**Description: East Wall
and Influent Gate
Opening General
Condition with
Spalling and Soft
Concrete**

**Location: Headworks
Building**

**Area: East Grit
Chamber**

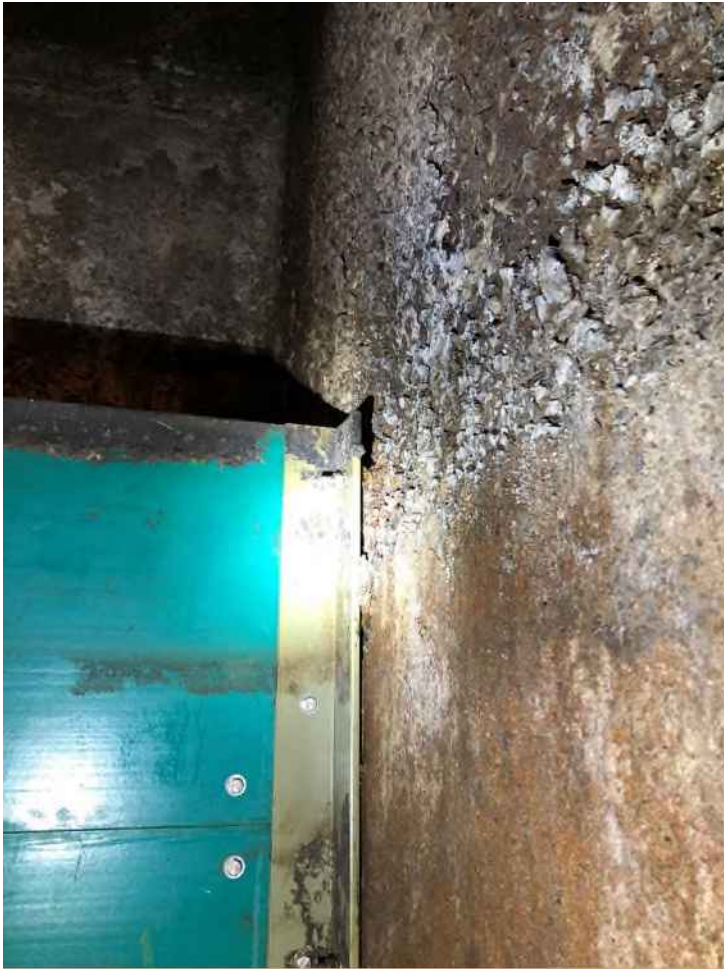
Photo No.: 13

**Description: Grit
Chamber Screen
Attachment to Wall**

**Location: Headworks
Building**

**Area: East Grit
Chamber**

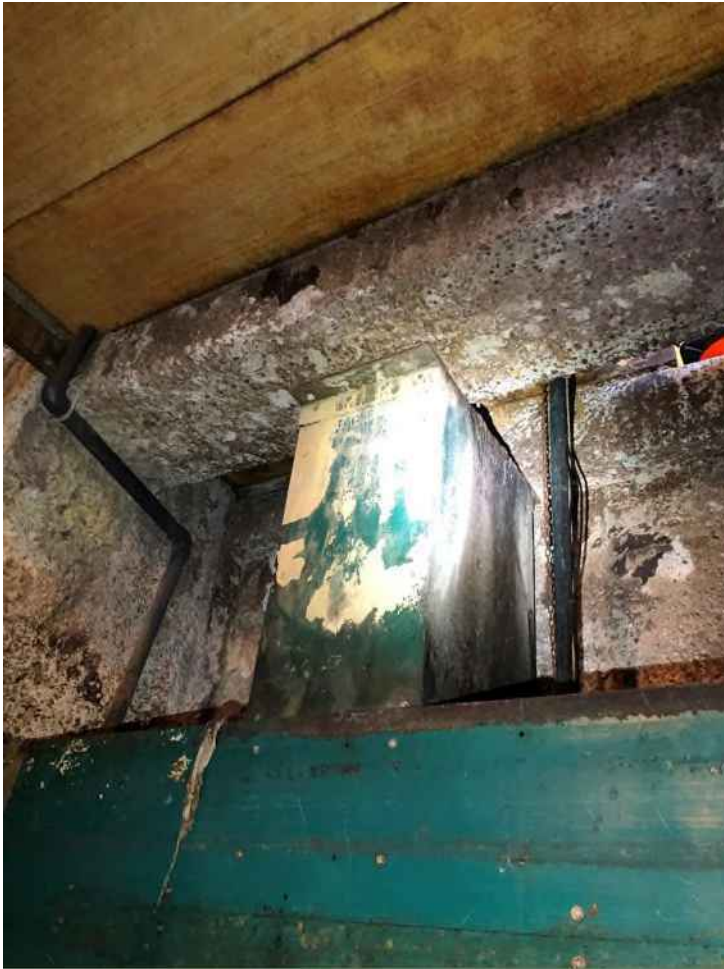
Photo No.: 14

**Description: South
Wall, Beam, and
Screen Paraphernalia**

**Location: Headworks
Building**

**Area: East Grit
Chamber**

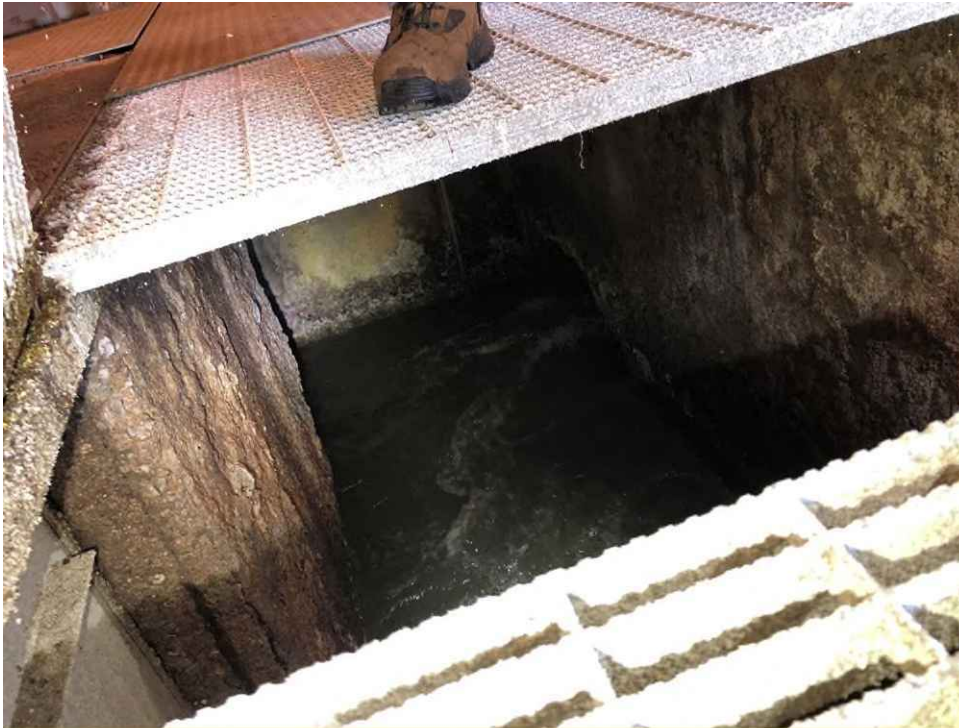
Photo No.: 15

**Description: General
Condition and
Exposed Aggregate**

**Location: Headworks
Building**

**Area: Effluent
Channel for West Grit
Chamber**

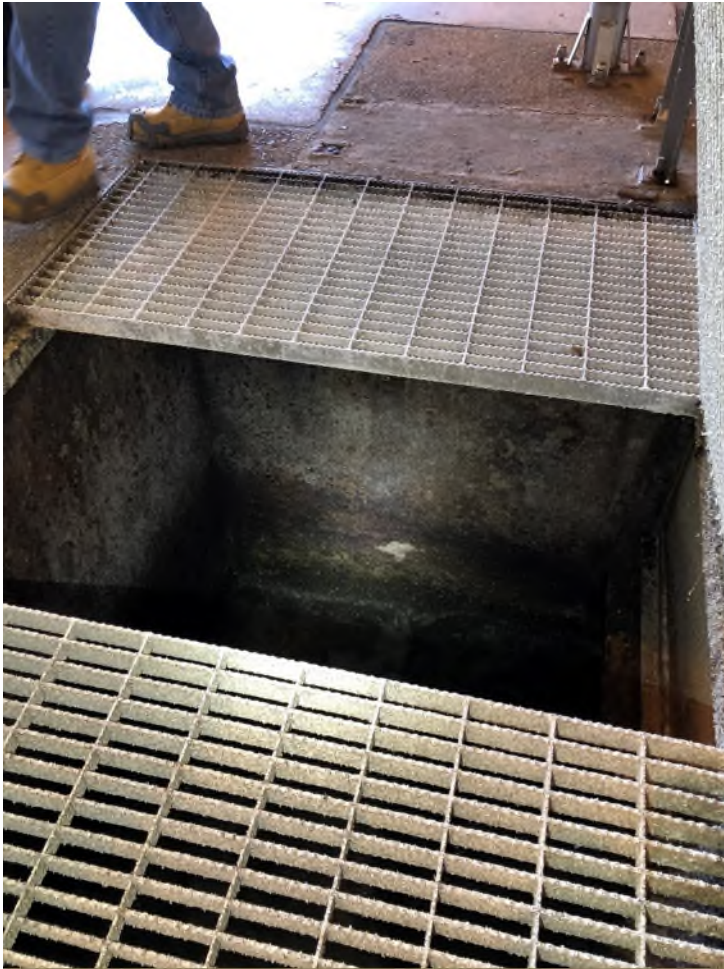
Photo No.: 16

**Description: General
Condition and
Exposed Aggregate**

**Location: Headworks
Building**

**Area: Effluent
Channel for West Grit
Chamber**

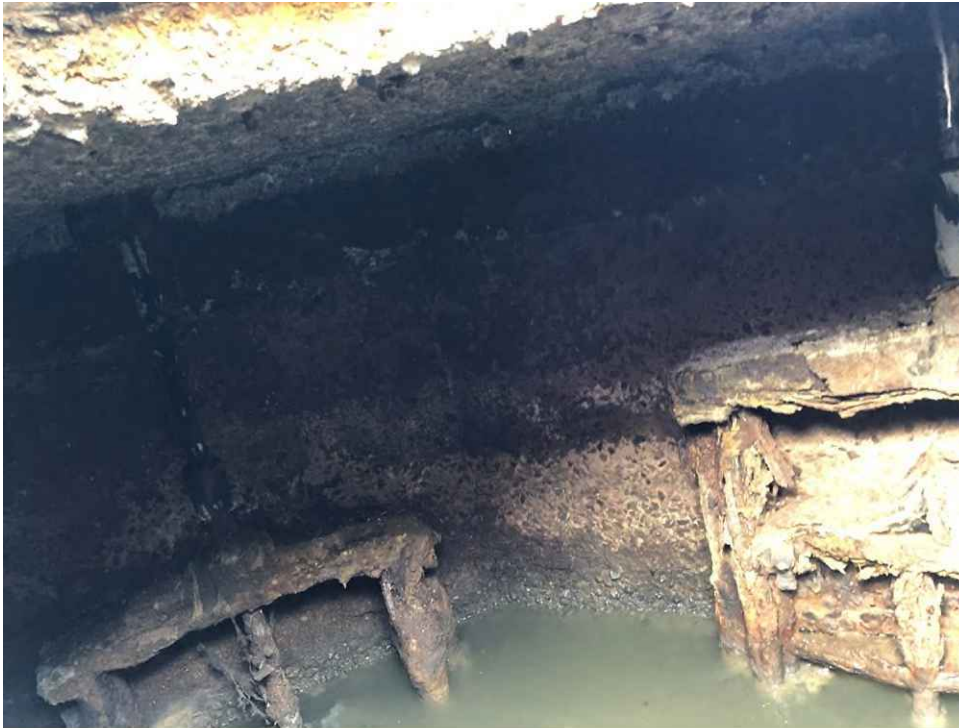
Photo No.: 17

**Description: Exposed
Aggregate and
Corroded Steel
Appurtenances**

**Location: Headworks
Building Manhole**

**Area: Grit Screening
Effluent Manhole**

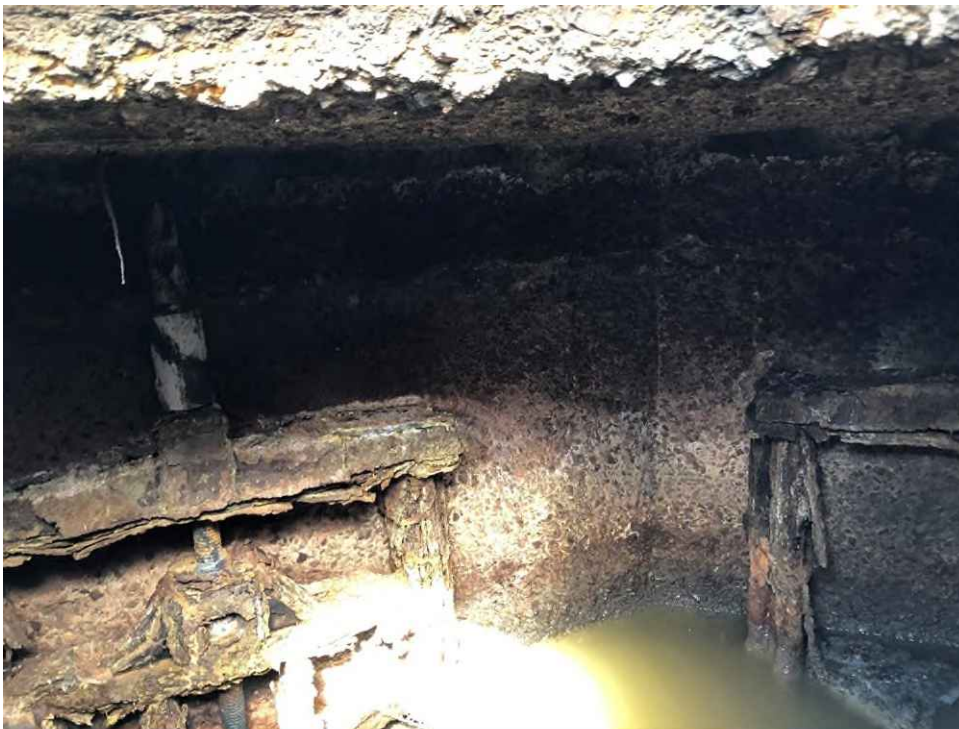
Photo No.: 18

**Description: Exposed
Aggregate and
Corroded Steel
Appurtenances**

**Location: Headworks
Building Manhole**

**Area: Grit Screening
Effluent Manhole**

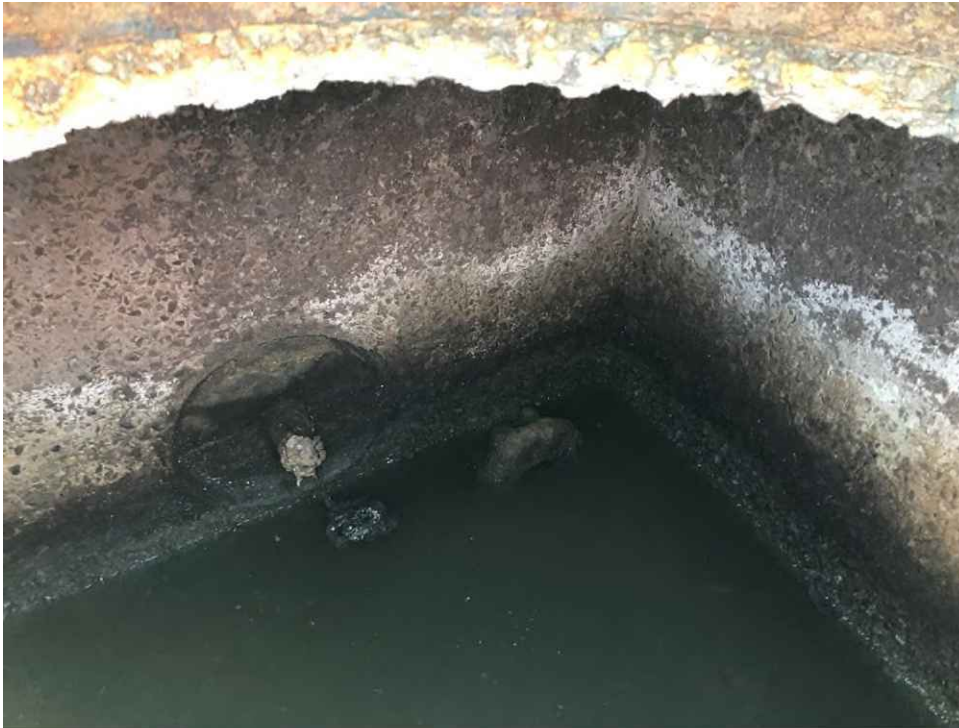
Photo No.: 19

Description: Exposed Aggregate and Efflorescence Staining

Location: Headworks Building Manhole

Area: Grit Screening Effluent Manhole

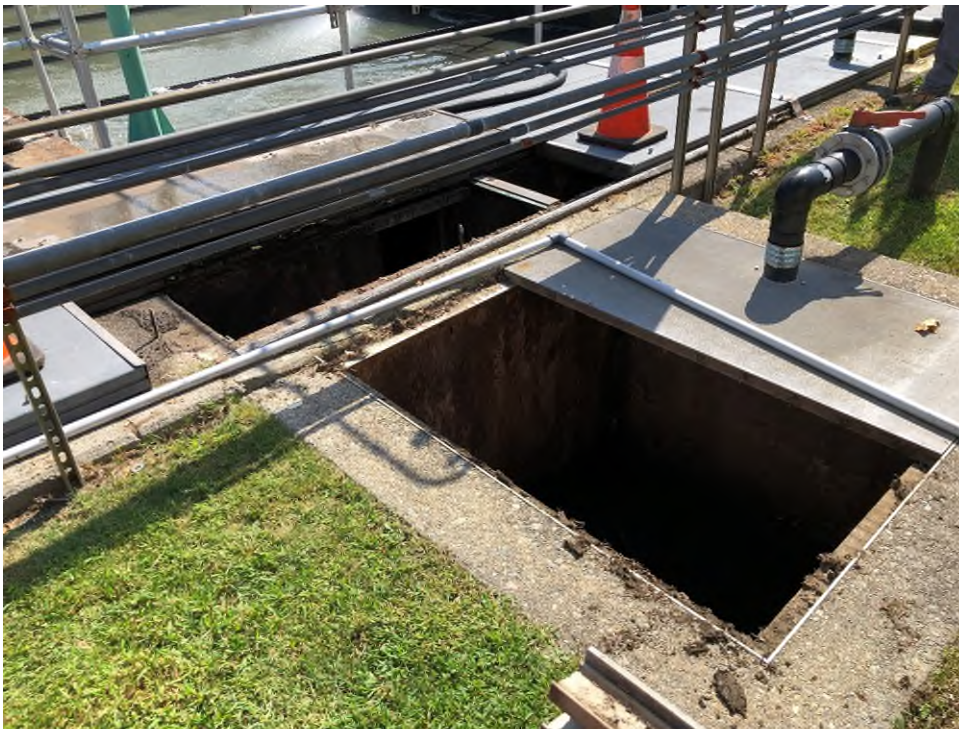
Photo No.: 20

Description: General Photo

Location: Primary Settling Tank 1 and 2

Area: Effluent Channel

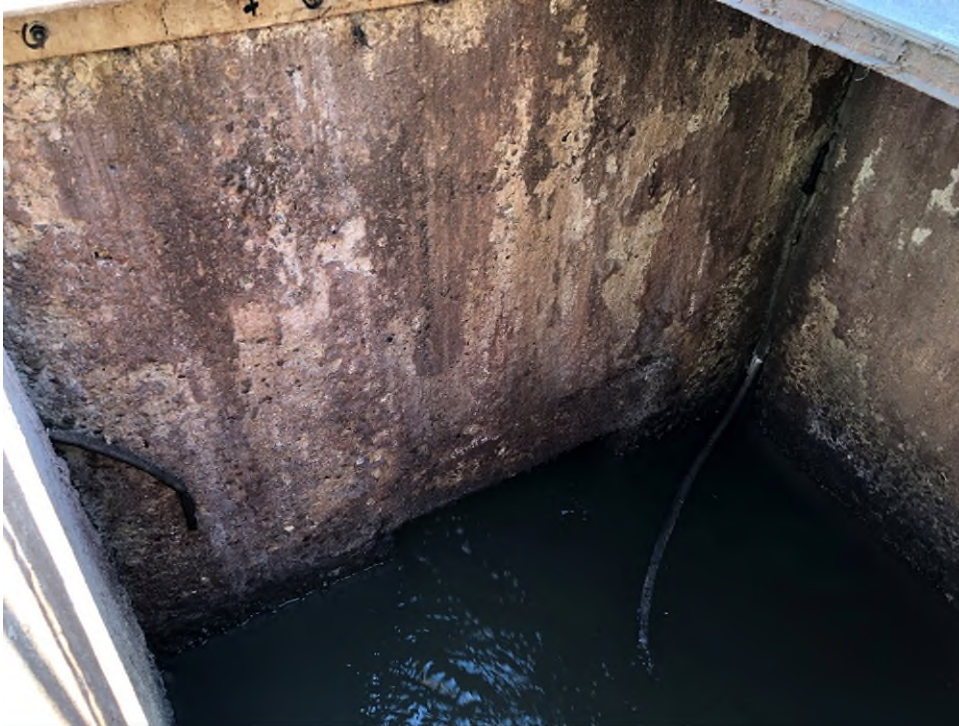
Photo No.: 21

Description: Exposed
Aggregate and
Exposed Reinforcing

Location: Primary
Settling Tank 1 and 2

Area: Effluent
Channel

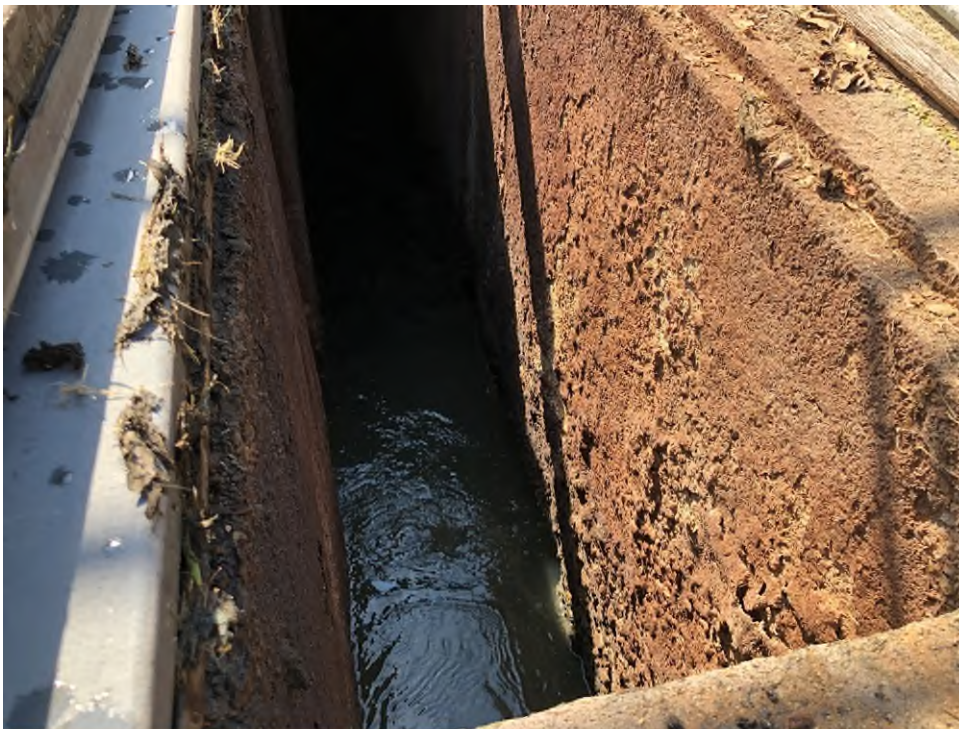
Photo No.: 22

Description: Exposed
Aggregate

Location: Primary
Settling Tank 1 and 2

Area: Effluent
Channel

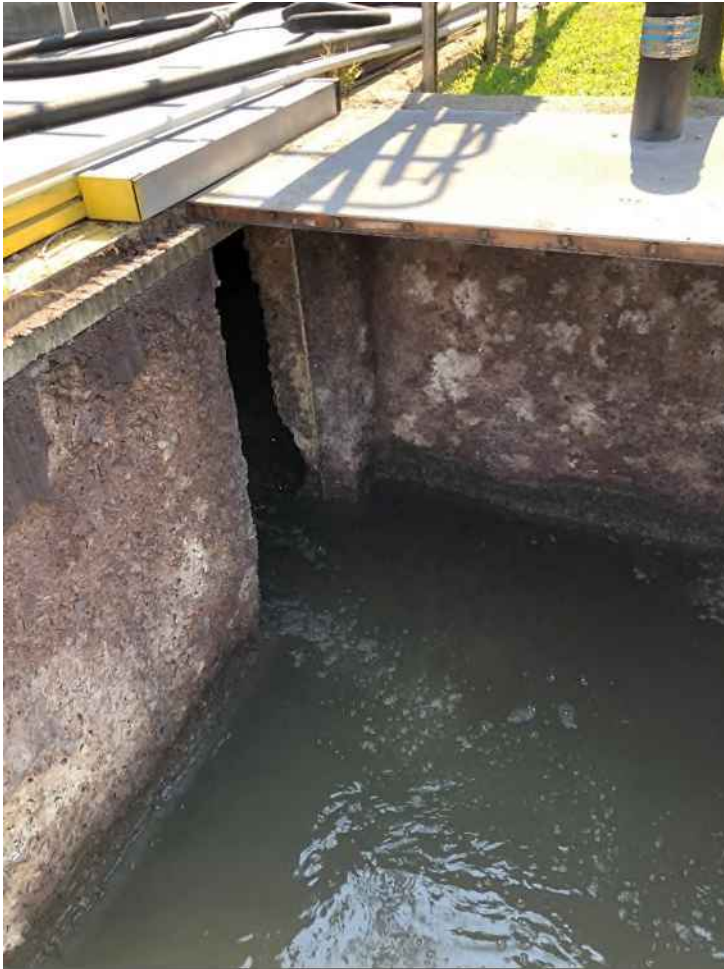
Photo No.: 23

**Description: Exposed
Aggregate and
Spalling**

**Location: Primary
Settling Tank 3 and 4**

**Area: Effluent
Channel**

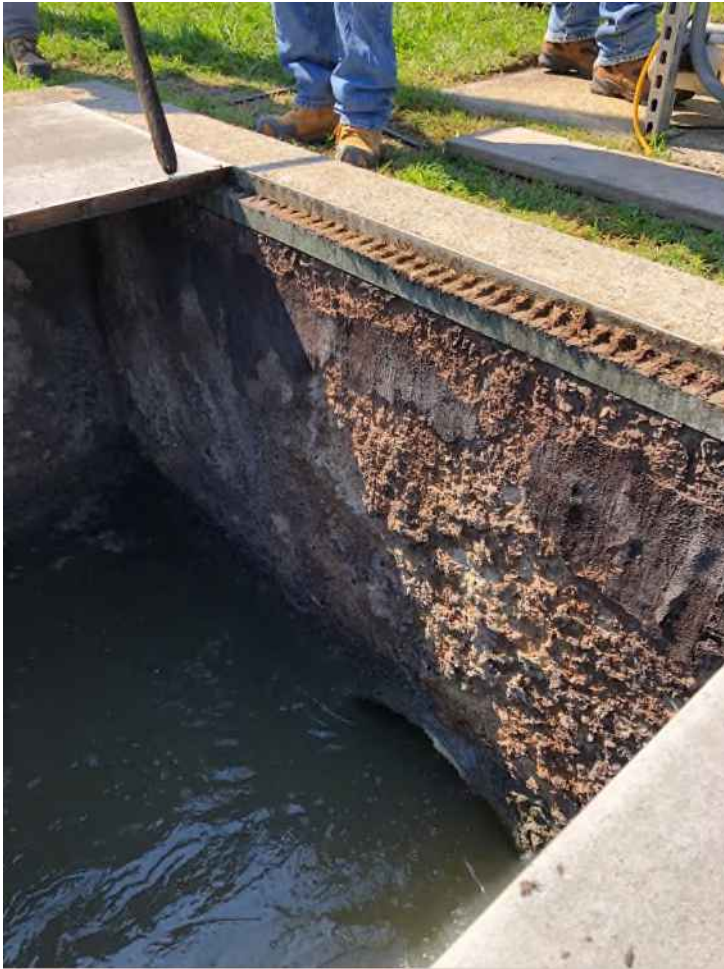
Photo No.: 24

**Description: Exposed
Aggregate and
Spalling.**

**Location: Primary
Settling Tank 3 and 4**

**Area: Effluent
Channel**

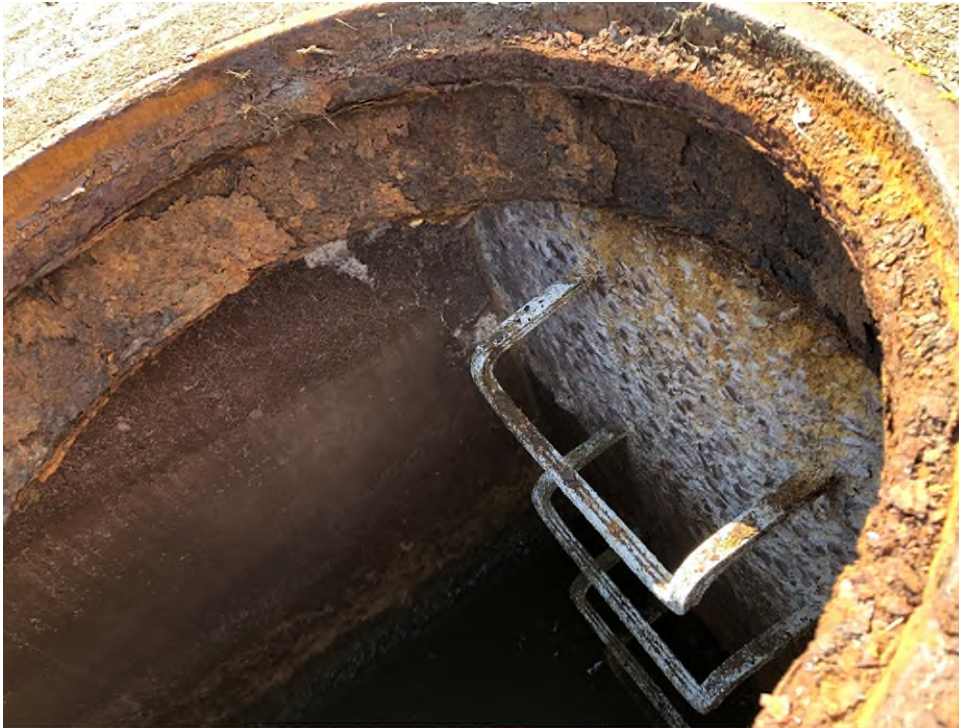
Photo No.: 25

**Description: Manhole
Frame Section Loss
and Exposed
Aggregate**

**Location: Top of
Manhole**

**Area: Primary Settling
Tank Effluent
Manhole**

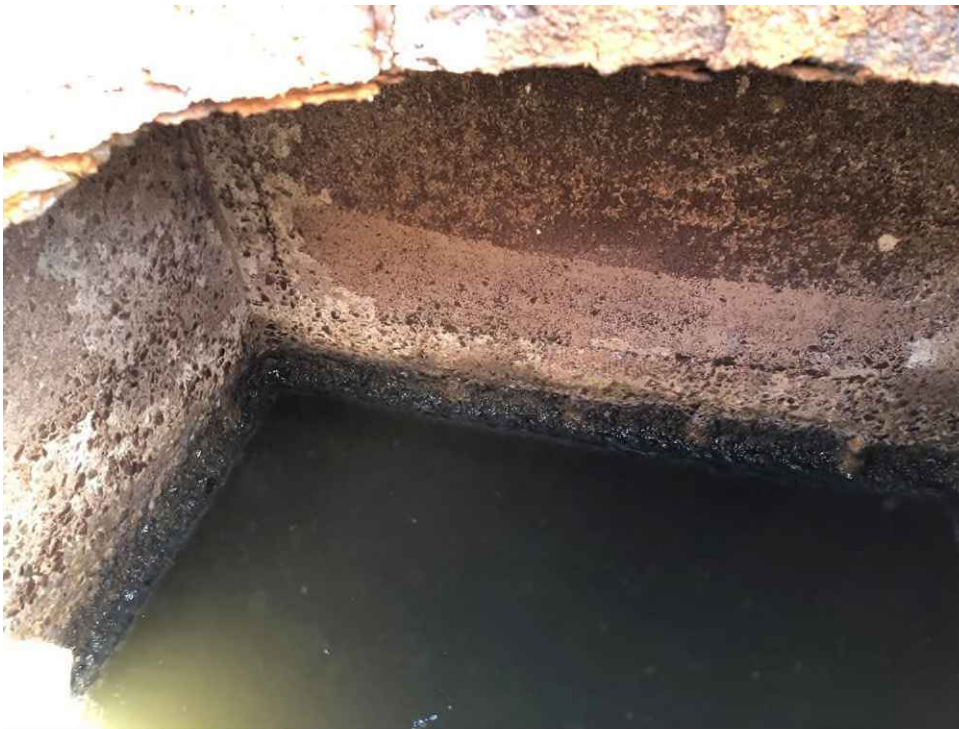
Photo No.: 26

**Description: Exposed
Aggregate, Exposed
Reinforcing and
Spalling at Water
Level**

**Location: Top of
Manhole**

**Area: Primary Settling
Tank Effluent
Manhole**

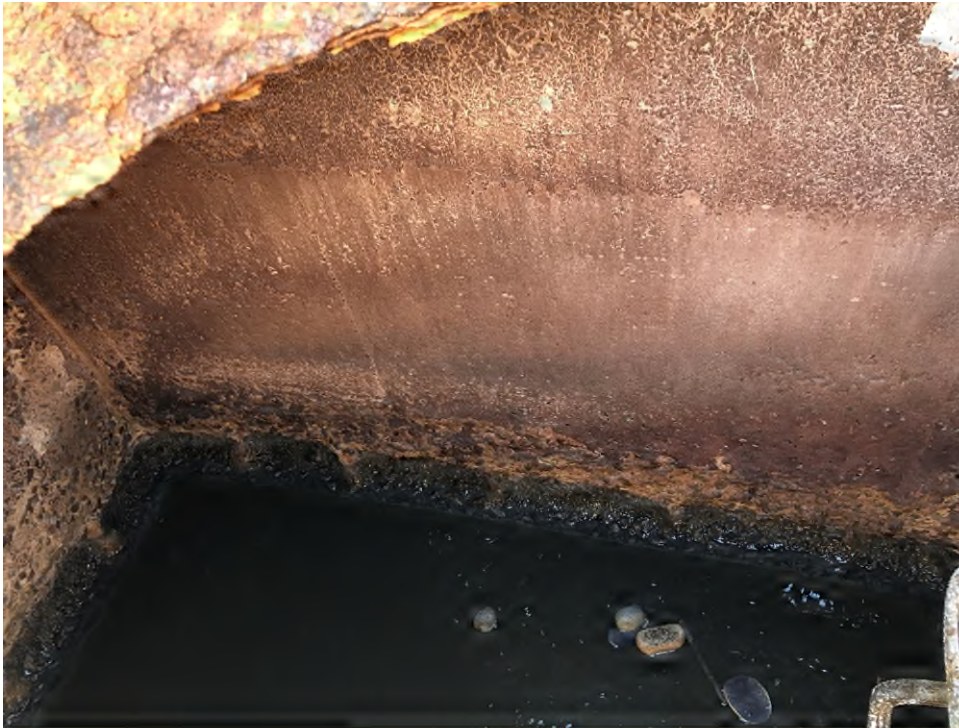
Photo No.: 27

Description: Exposed Reinforcing and Spalling at Water Level

Location: Top of Manhole

Area: Primary Settling Tank Effluent Manhole

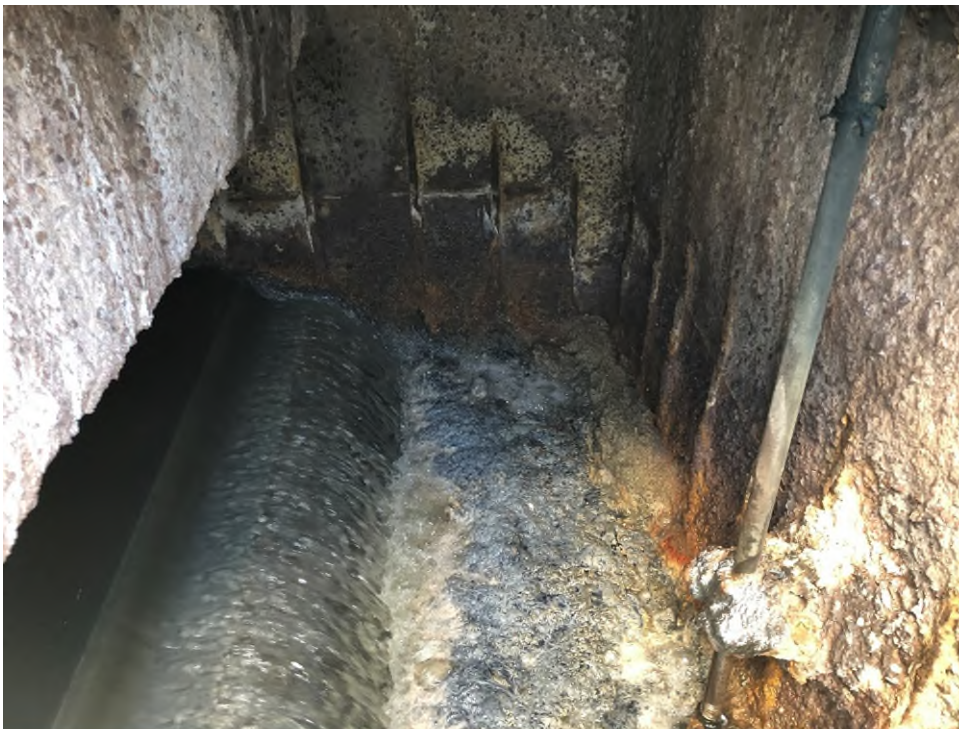
Photo No.: 28

Description: Wall Spalling Exposing Reinforcing with Section Loss

Location: Primary Flow Splitting Structure

Area: Northeast Grating Section

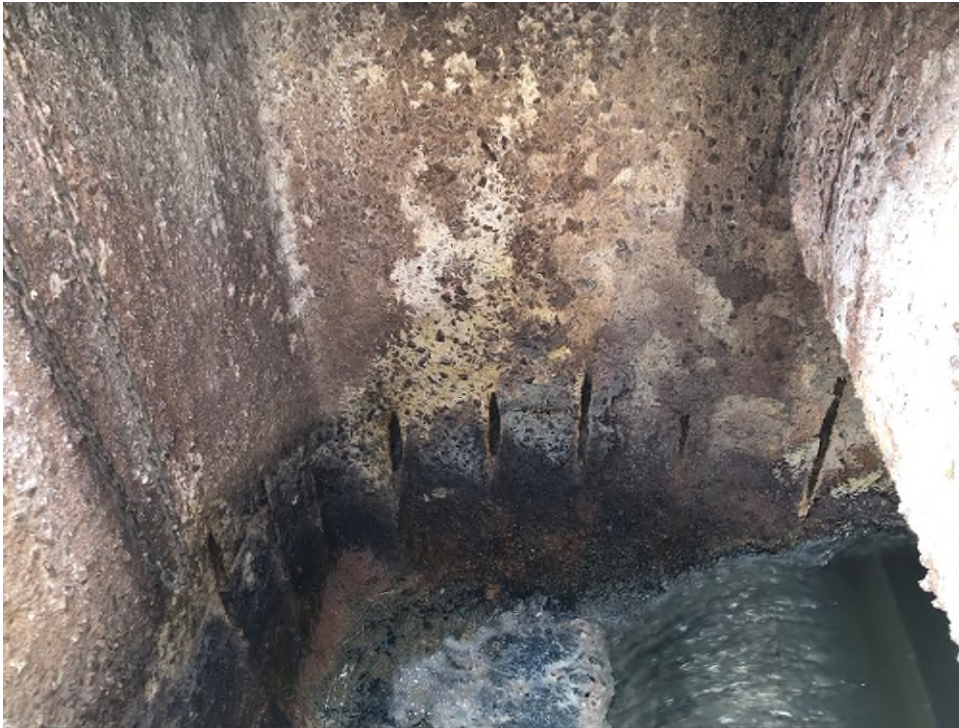
Photo No.: 29

Description: Wall Spalling Exposing Reinforcing with Section Loss

Location: Primary Flow Splitting Structure

Area: Northeast Grating Section

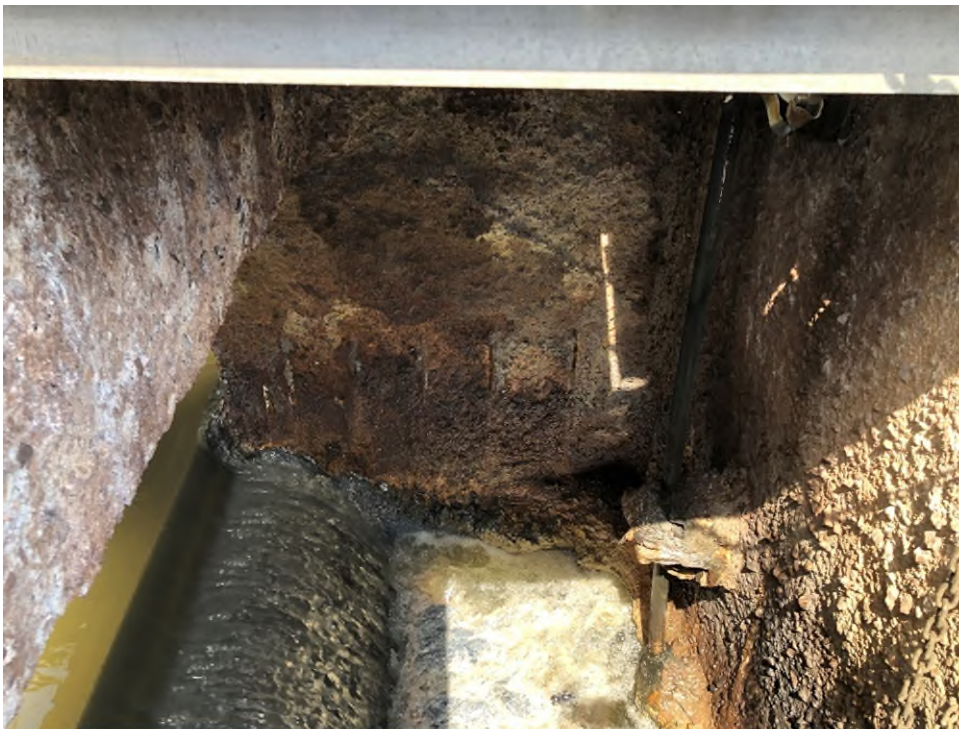
Photo No.: 30

Description: Wall Spalling Exposing Reinforcing with Section Loss

Location: Primary Flow Splitting Structure

Area: Southeast Grating Section

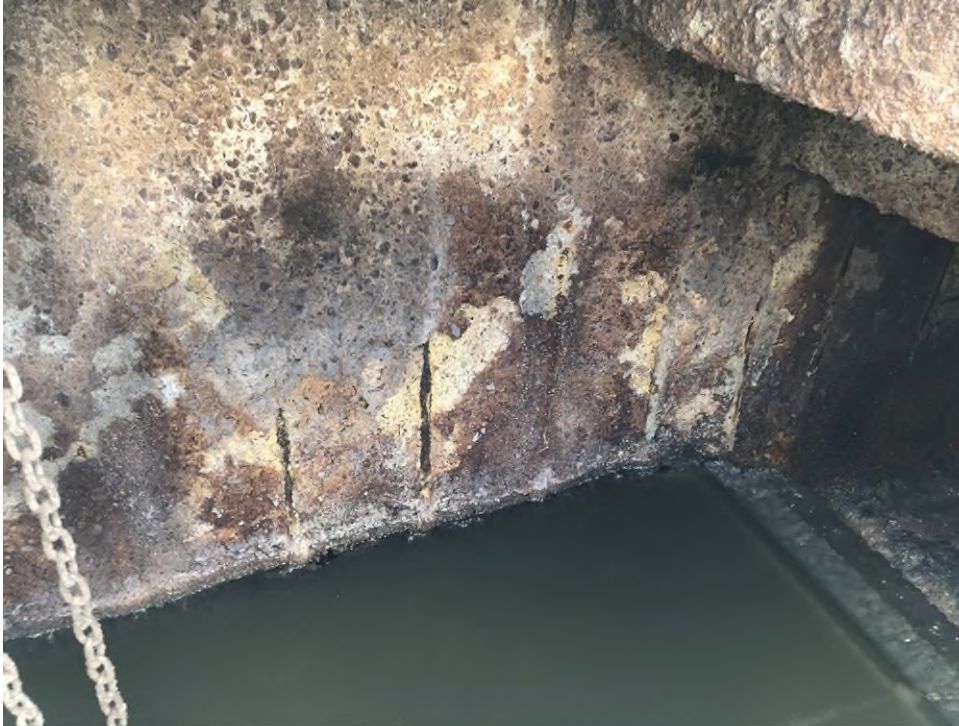
Photo No.: 31

**Description: Wall
Spalling Exposing
Reinforcing with
Section Loss**

**Location: Primary
Flow Splitting
Structure**

**Area: Southeast
Grating Section**
