Appendix C – WPCF Concrete Inspection Photograph Log

Project: East Providence, RI WPCF - Structural Assessment and Rehabilitation Design
Date: September 8th, 2021

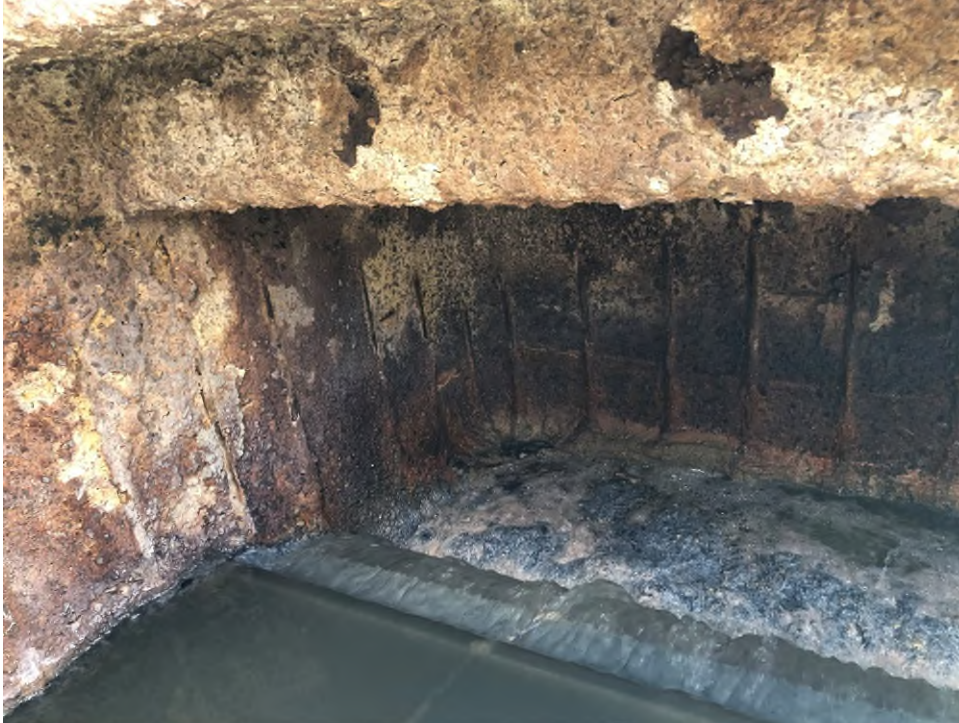
Photo No.: 32

**Description: Wall
Spalling Exposing
Reinforcing with
Section Loss**

**Location: Primary
Flow Splitting
Structure**

**Area: Center Grating
Section**

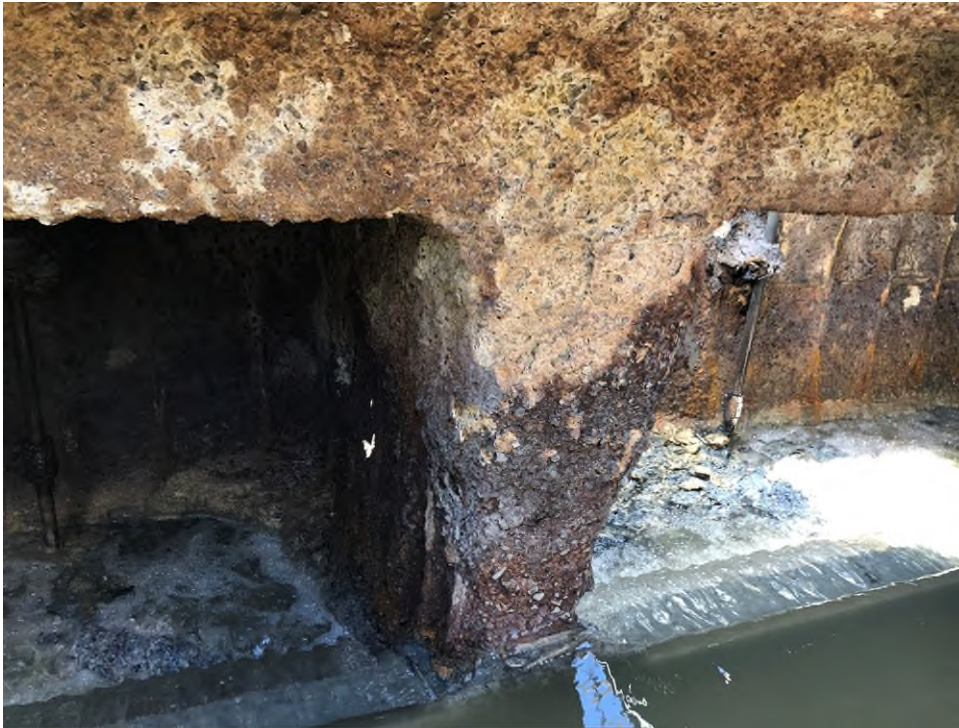
Photo No.: 33

**Description: Wall
Spalling Exposing
Reinforcing with
Section Loss**

**Location: Primary
Flow Splitting
Structure**

**Area: Center Grating
Section**

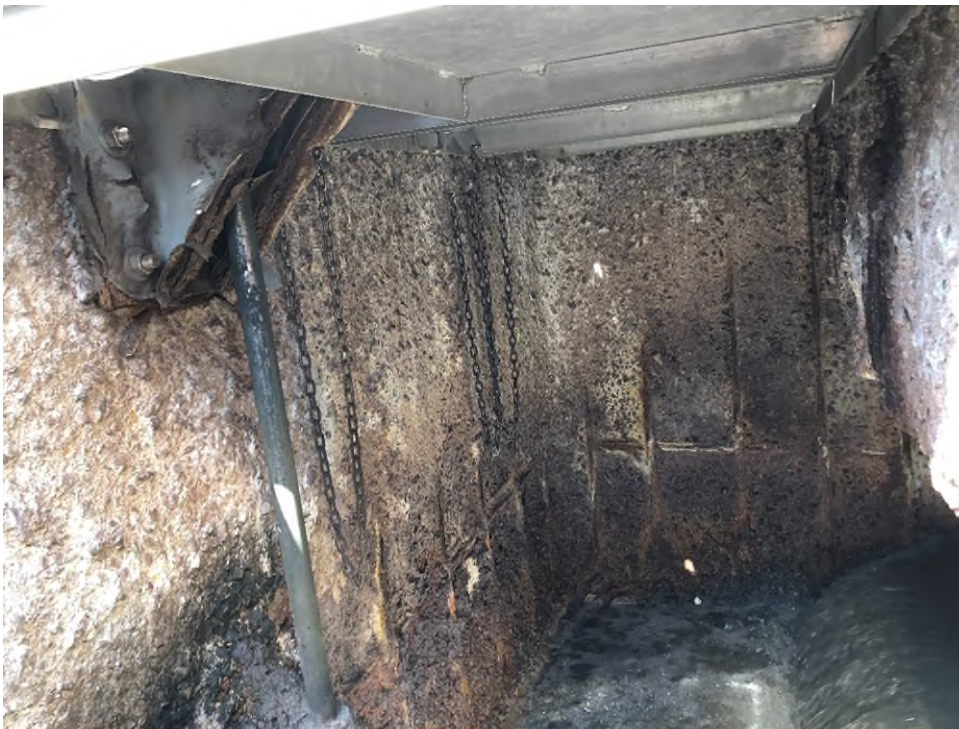
Photo No.: 34

**Description: Wall
Spalling Exposing
Reinforcing with
Section Loss**

**Location: Primary
Flow Splitting
Structure**

**Area: Northwest
Grating Section**

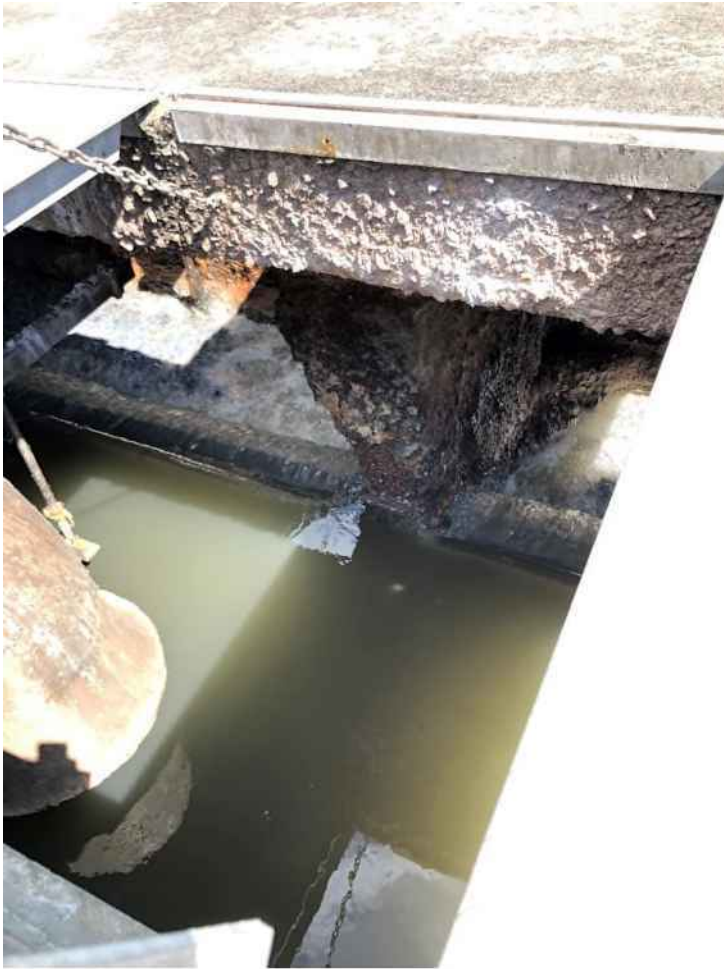
Photo No.: 35

**Description: Wall
Spalling Exposing
Reinforcing with
Section Loss**

**Location: Primary
Flow Splitting
Structure**

**Area: Northwest
Grating Section**

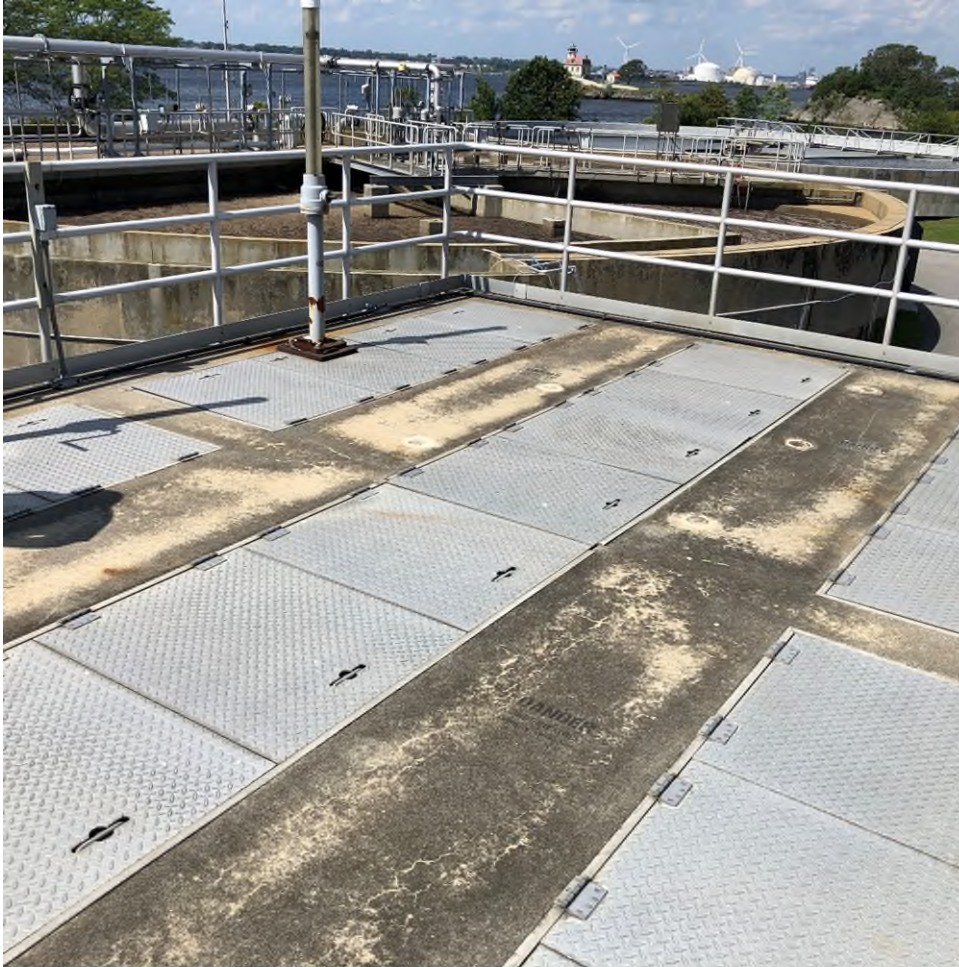
Photo No.: 36

**Description: General
Structure Top Slab**

**Location: Primary
Flow Splitting
Structure**

Area: Top Slab

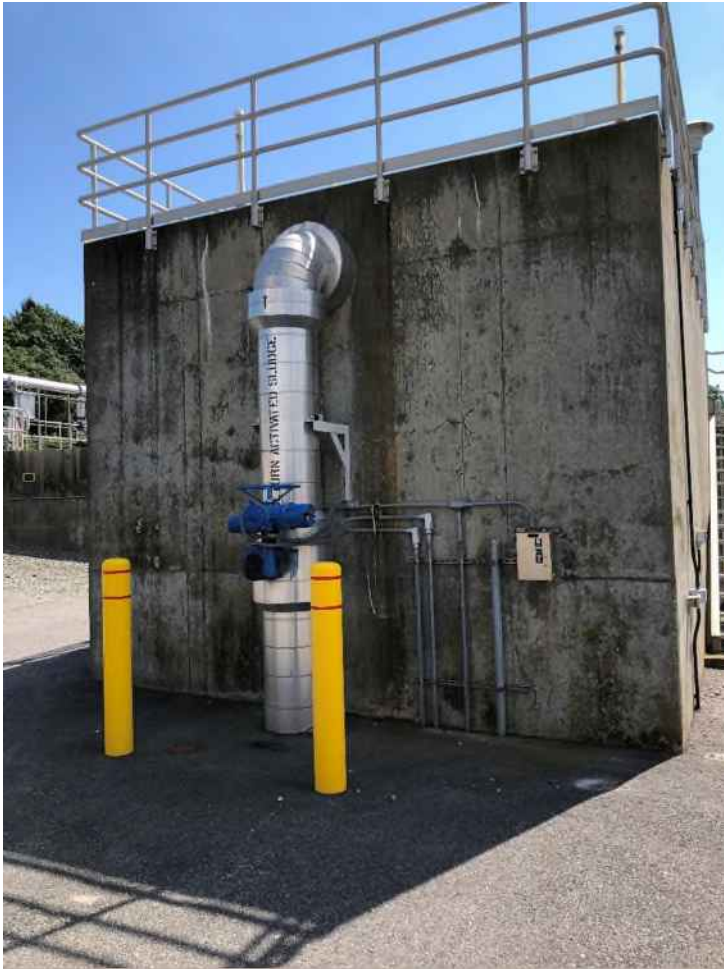
Photo No.: 37

**Description: Wall
General Condition,
Several Cracks with
Efflorescence
Staining**

**Location: Primary
Flow Splitting
Structure**

Area: North Wall

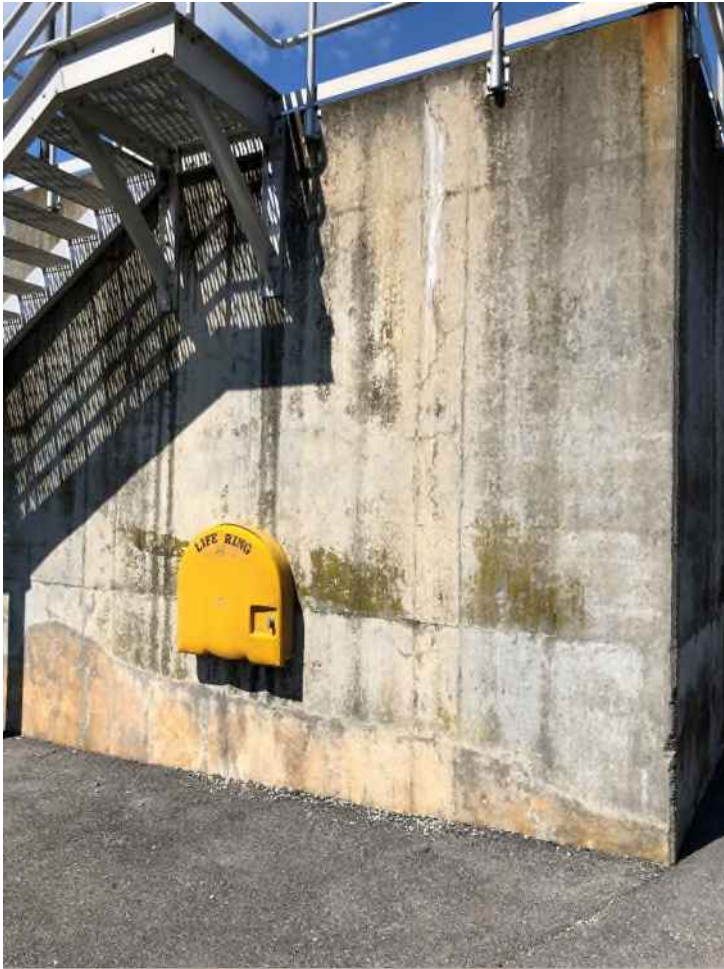
Photo No.: 38

**Description: Wall
General Condition,
Several Cracks with
Efflorescence
Staining**

**Location: Primary
Flow Splitting
Structure**

Area: South Wall
