Appendices

Appendix 1: Cultural Resource Survey Forms

Rhode Island Historical Preservation & Heritage Commission HISTORIC PROPERTY DATA FORM

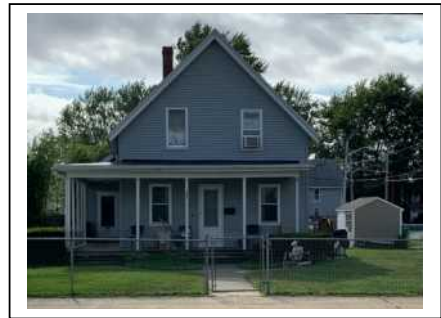
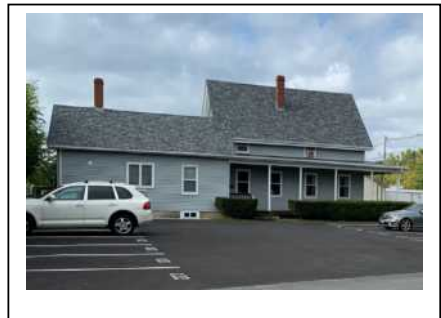
Photo ID EAPR_233Bullockspointave_W

Photo ID EAPR_233Bullockspointave_NE

It is the opinion of this statement that although 233 Bullocks Point Avenue is situated on Riverside Square and are likely to be significant within Criterion A, 233 Bullocks Point Avenue has lost its historic integrity. Due to a lack of integrity, the building cannot display its significance within its respective historic context and therefore are unlikely eligible for the National Register. Finally, it should be noted that if there was restoration of 233 Bullocks Point Avenue with the original intended material this would likely rehabilitate its integrity.

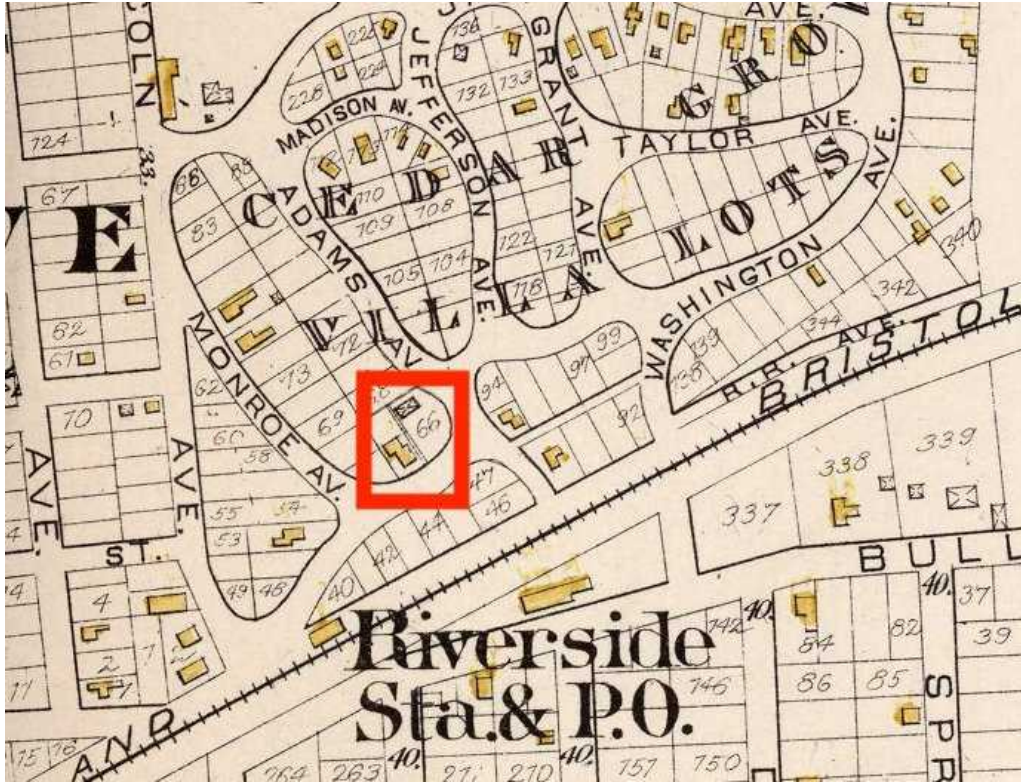
Figure 1. Map of Riverside, 1882, showing original footprint of building.

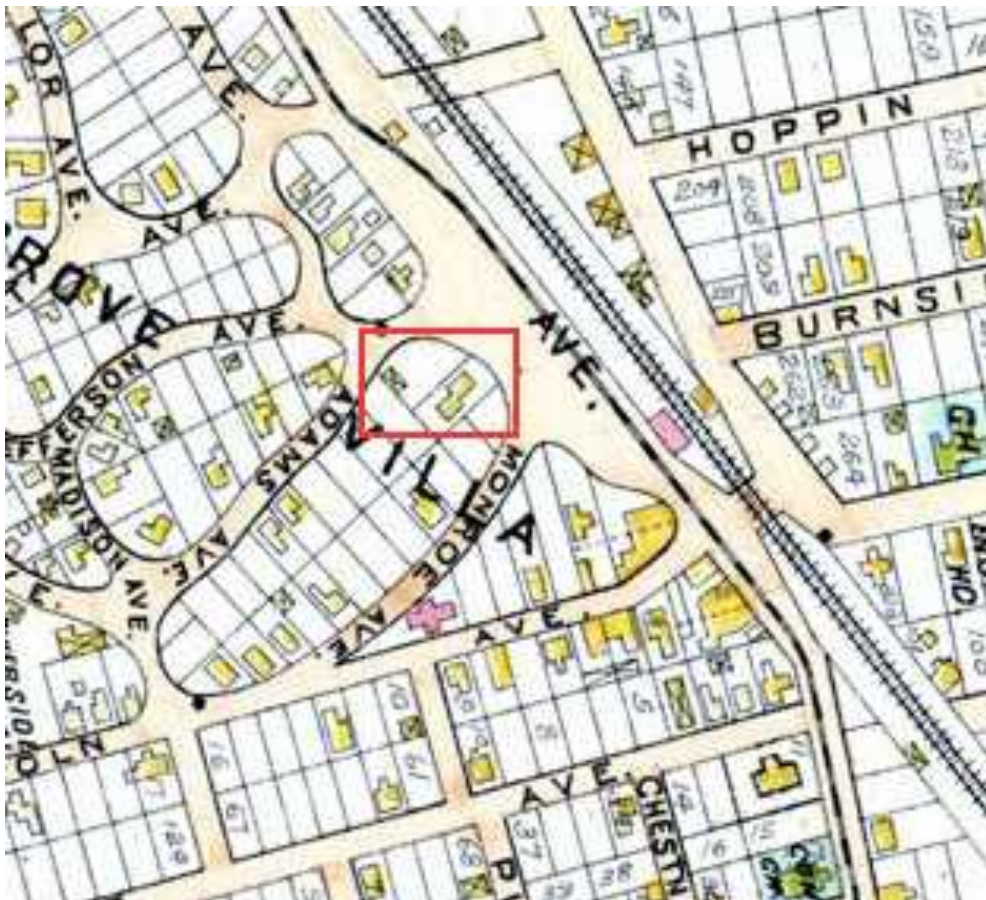
Figure 3. Close up of 233 Bullocks Point Avenue footprint, 1895.

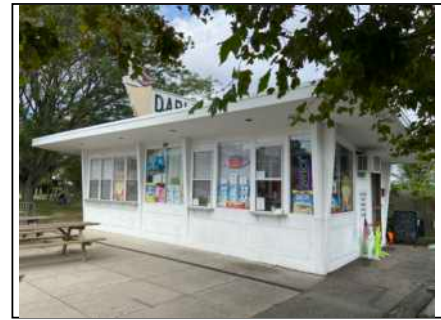
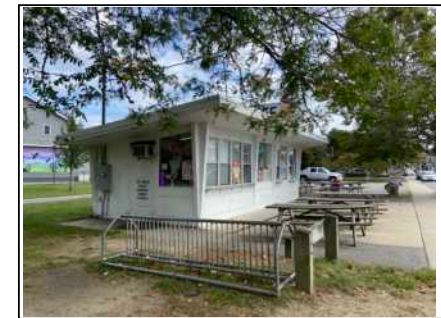
Photo ID EAPR_BullocksPtAve_E

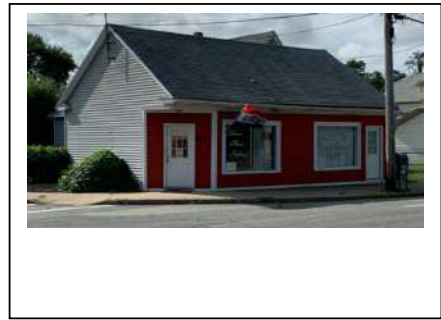
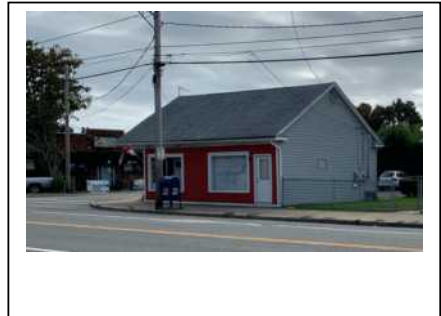
Photo ID EAPR_241Bullockspointave_NE

Photo ID EAPR_241Bullockspointave_NW

It is the opinion of this statement that although 241 Bullocks Point Avenue is situated on Riverside Square and are likely to be significant within Criterion A, 241 Bullocks Point Avenue has lost its historic integrity. Due to a lack of integrity, the building cannot display its significance within its respective historic context and therefore are unlikely eligible for the National Register. Finally, it should be noted that if there was restoration of 241 Bullocks Point Avenue with the original intended material this would likely rehabilitate its integrity.

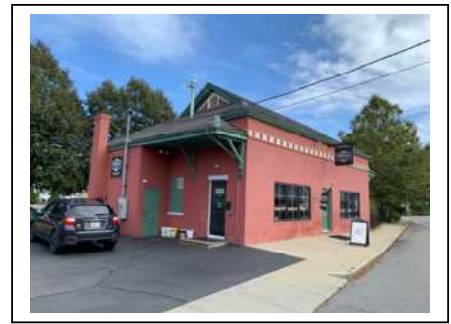
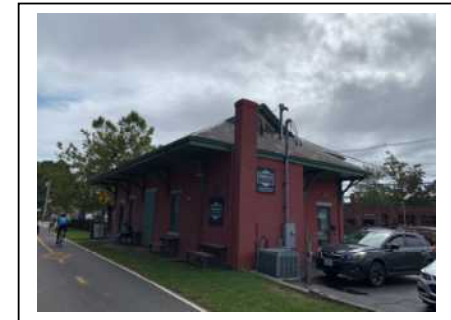
Photo ID EAPR BullocksPtAve250 E

Photo ID EAPR BullocksPtAve250 S

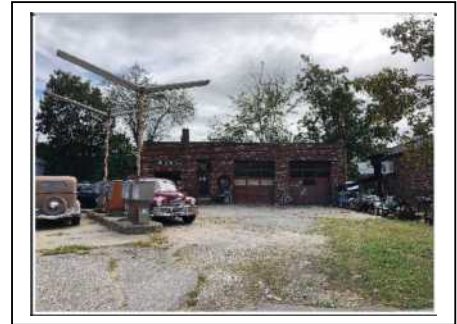
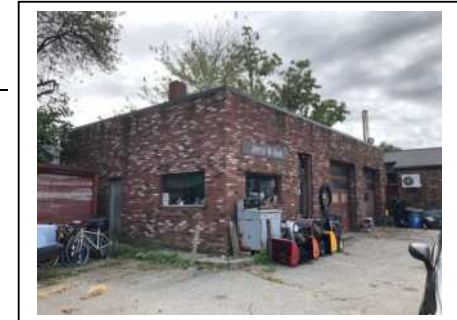
Photo ID EAPR BullocksPointAve255 S

Photo ID EAPR BullocksPointAve SW

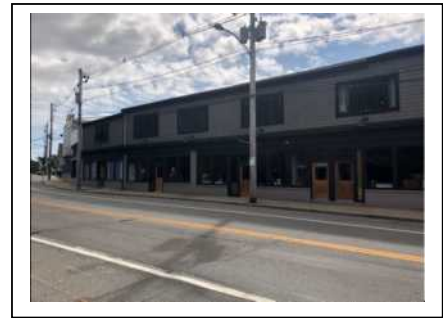
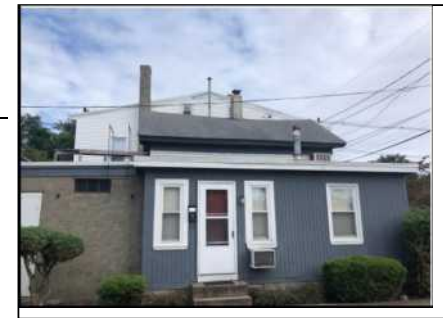
Photo ID EAPR_Bullocksptave_W

Photo ID EAPR_Bullockspointave_E

Integrity: 273-279 Bullocks Point Avenue retains the integrity of location and design. There have been alterations to the building resulting in a lack of integrity in the aspects of materials, workmanship, and associations. As previously mentioned with the recent renovations in the past several years all windows have been replaced, window arrangements altered as well as overall material and style moderately to majorly changed. There is still feeling, as the massing is nearly identical to its historic presence, and it frames the square.

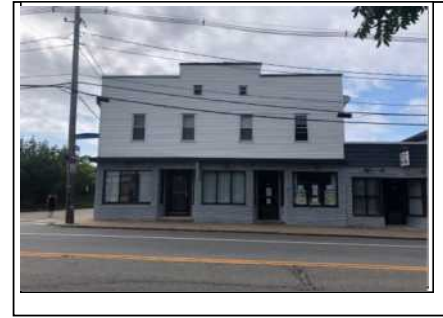
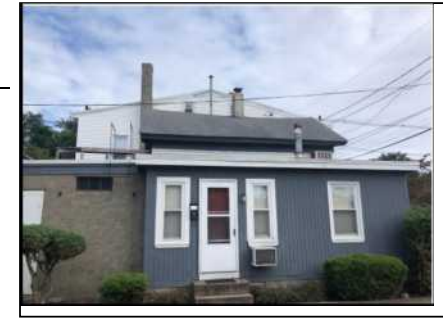
Photo ID EAPR Bullocksptave W

Photo ID EAPR Bullcokspointave E

285-289 Bullocks Point Avenue is a two-story mixed-use commercial building with no real style due to the high level of alterations. The earliest portion of the building is the rear ell, which was constructed ca. 1850 as a small one-and-a-half-story Victorian dwelling with an end gable roof. It is noted that it was for the time a very nice example of a Riverside summer cottage that was chastely decorated with a two-sided porch built by the Riverside Land Company.¹ Over time the building was expanded into the commercial building present today. The building has a generally rectangular footprint, despite the rambling nature of the additions over time. It is located at the intersection of Maple Avenue and Bullocks Point Avenue, with the eastern facade facing the main road of Bullocks Point Ave. whilst composed, of permastone, and stucco on the front and rear facades on the ground floor, with vinyl cladding on the second story. The building has a gable asphalt shingle roof on the main and secondary roofs. The main facade is street-facing and has three main storefront sections, the foundation is concrete and only visible on the rear and side facades where there is not permastone covering surrounding the groupings of 3 single pane storefront windows, each accompanied by a door per storefront. The second story is clad in vinyl siding and features evenly spaced one over one double-hung vinyl windows that are all replacements. The south side elevation is on the corner of Maple Avenue with the rear ell abutting to a parking lot. The rear additions feature a mix of all of the previous cladding materials, with one addition appearing to previously have been a garage.

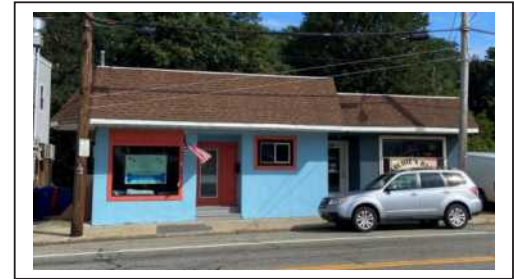
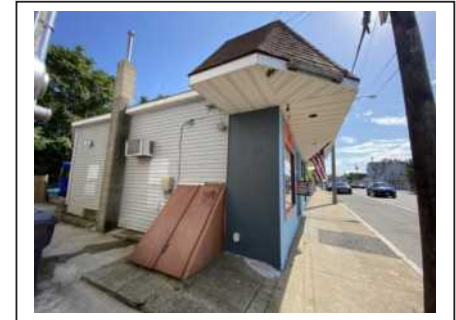
Photo ID EAPR_BullocksPtAve290-292_E

Photo ID EAPR_BullocksPtAve290-292_S

290-292 Bullock's Point Ave. does not appear eligible for listing in the National Register of Historic Places under Criteria C. It is a one-story commercial block with two storefronts. There have been modifications to the cladding on the sides and rear, now vinyl, also the roof, windows, and window trim. The entrances have also likely been altered with the doors having been replaced. There is nothing of high artistic value, nor are there distinctive characteristics of this type, period, and method of construction. It is ordinary, unremarkable, and common in type and style.

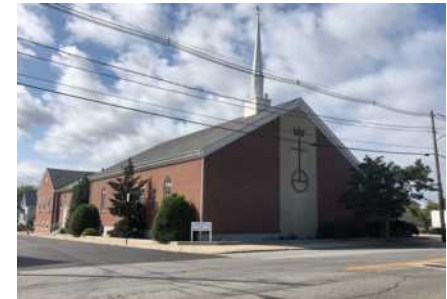
Photo ID EAPR_BullocksPointAve295_NW

ROOF Asphalt WALL Brick

FOUNDATION Concrete OTHER _____

WINDOWS Vinyl double-hung and awning sash

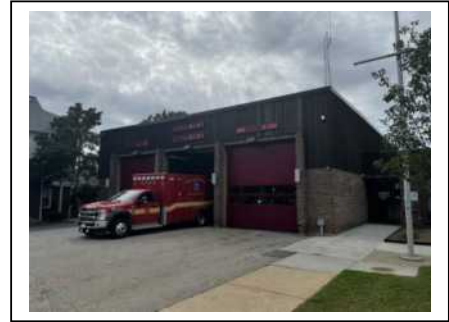
Photo ID EAPR BullocksPoint329 SW

FOUNDATION Concrete OTHER Aluminum

WINDOWS Aluminum double-hung (1 over 1)

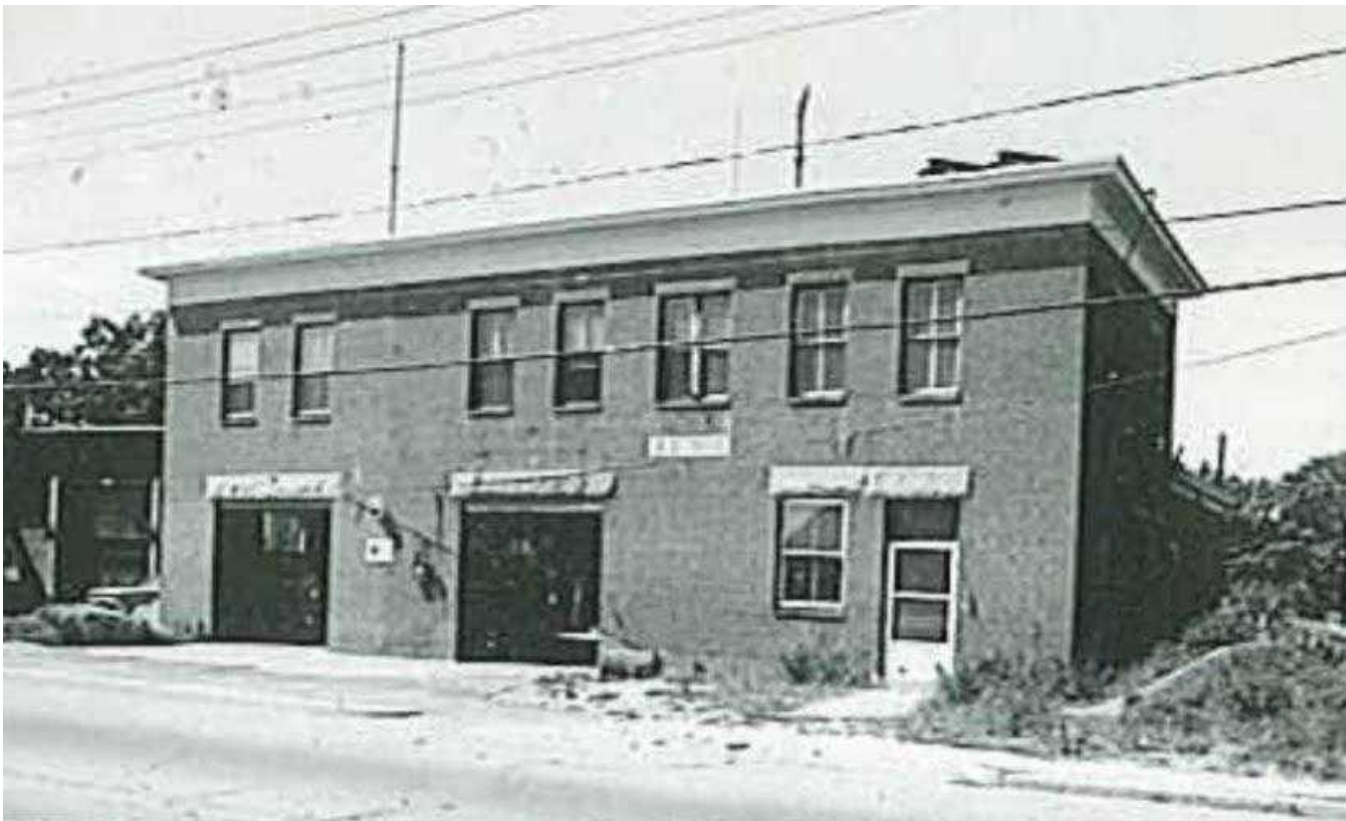
A historic image of the 1908 fire station, later demolished in 1975 and replaced in 1976. Although this building housed both the engine company and police for Riverside, the station is clearly smaller with what seems to be most of the first floor dedicated to garage space. The building is also not set back from the street, a result of its 1908 built date. Source: RIHPHC 1975 Survey Forms.

The first building on this site was also a fire station but also housed the police department while it was standing (Sanborn Map 1956). Built in 1908, the original 329 Bullocks Point Avenue station was a simple, nearly square two-story brick building with two garage doors leading directly onto the street. At this time, the fire department in Riverside was the Narragansett Engine Company No. 2 and before they built this new station, they operated out of the building at 9 Turner Avenue (East Providence City Directory 1892). The 1908 station at 329 Bullocks Point Ave served as the home of the police and fire department until 1975 when it was replaced by the larger, modern building that exists today (RIHPHC Survey Forms 1975). While the current station is larger, it only houses the fire department as police and fire units grew larger over time. Along with the new station being built, the fire department in Riverside got its current name, East Providence Fire Station 2 (East Providence City Directory 1976). As the current building is larger, it also has an additional, third garage bay, which allows for the East Providence ambulance rescue crew number 2 to operate alongside the fire department. The current building has been acting successfully as the Riverside fire station since it was built.

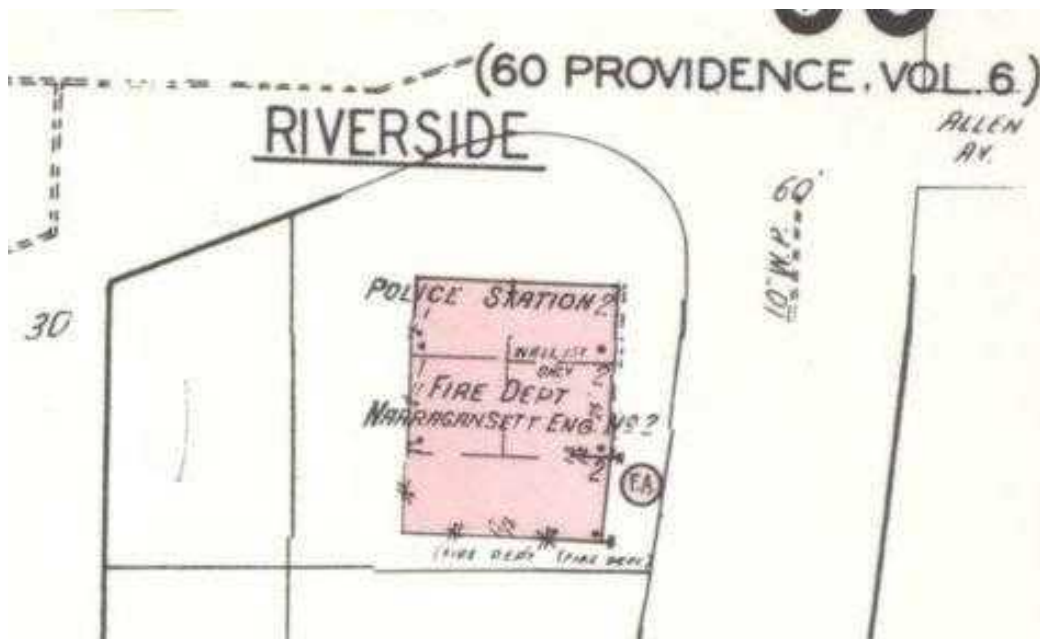
Sanborn map from 1956 showing the nearly square footprint of the old station which was demolished in 1975. The map shows the inclusion of the police department which no longer operates from this site. Source: 1956 Sanborn Fire Insurance map of East Providence (based on vol. 6 of the 1921 edition).

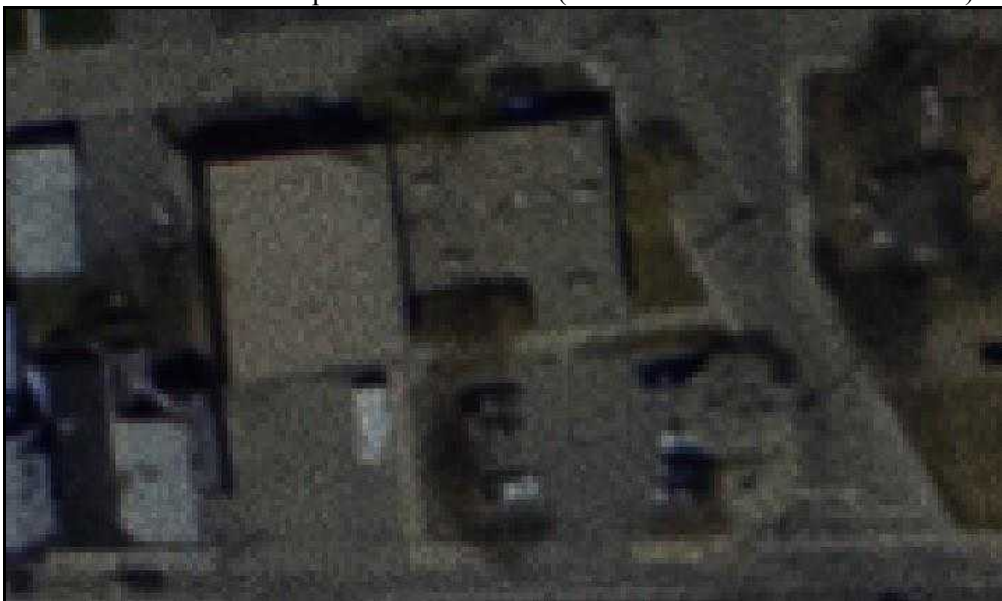
This Google Earth image shows the J-shaped footprint of the current fire station and its increased setback from the street for a driveway and parking lot. Source: Google Earth.

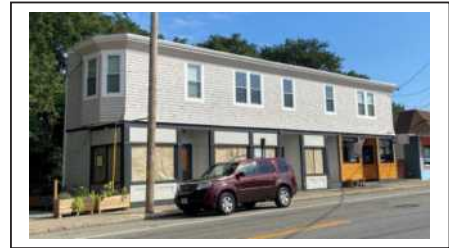
Photo ID EAPR 332BullocksPtAve SE

CURRENT Multiple dwelling, business HISTORIC _____
 SITING: SETBACK >10 ft LOT SIZE 2614 sq ft
 STORIES 2 ROOF(s) flat

ROOF Wood, rubber WALL Wood shingle, clapboard
 FOUNDATION concrete OTHER _____
 WINDOWS Large single pane fixed storefront, double-hung 1/1 (2nd story),

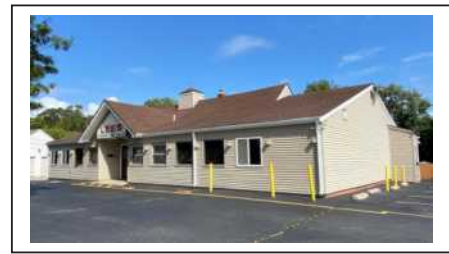
Photo ID EAPR 376BullocksPtAve NE

FOUNDATION concrete OTHER metal

WINDOWS Double- hung 1/1, sliding, large single pane fixed

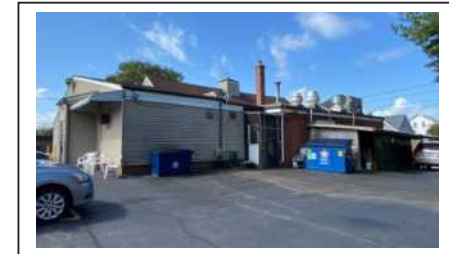
Photo ID EAPR_376BullocksPtAve_S W

ALTERATIONS:	PORCH	WINDOWS	TRIM	OVERALL
Material	Maj Mod Min None	Maj <input checked="" type="radio"/> Mod <input type="radio"/> Min <input type="radio"/> None <input type="radio"/>	<input checked="" type="radio"/> Maj <input type="radio"/> Mod <input type="radio"/> Min <input type="radio"/> None <input type="radio"/>	<input checked="" type="radio"/> Maj <input type="radio"/> Mod <input type="radio"/> Min <input type="radio"/> None <input type="radio"/>
Configuration	Maj Mod Min None	Maj <input checked="" type="radio"/> Mod <input type="radio"/> Min <input type="radio"/> None <input type="radio"/>	<input checked="" type="radio"/> Maj <input type="radio"/> Mod <input type="radio"/> Min <input type="radio"/> None <input type="radio"/>	<input checked="" type="radio"/> Maj <input type="radio"/> Mod <input type="radio"/> Min <input type="radio"/> None <input type="radio"/>

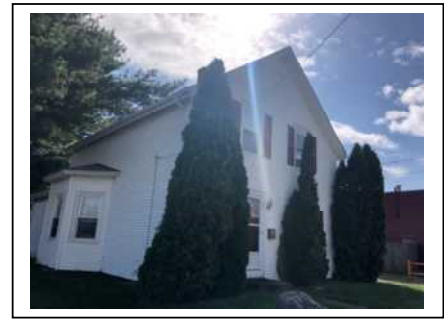
Photo ID EARP BurnsideAve27 SE

FOUNDATION Brick OTHER _____

WINDOWS 6/1 double hung sash, 1/1 double hung sash, Vinyl replacements

The property does appear eligible under Criterion C. Sidehall dwellings such as this are common architectural types in the area, but this property has been substantially altered with porch removal, additions, and materials replacement.

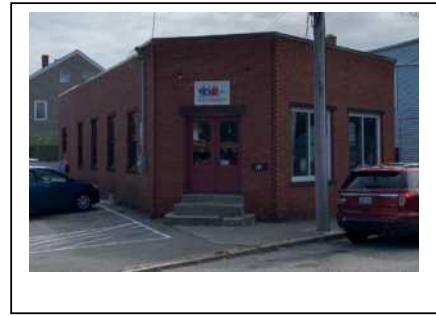
Photo ID EAPR_LincolnAve010_SW

FOUNDATION Not visible OTHER _____

WINDOWS (1) Two-light fixed sash vinyl (2) One-over-one double hung sash vinyl

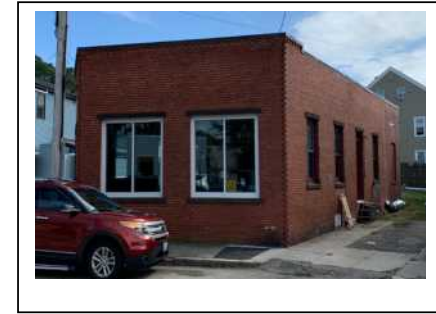
Photo ID EAPR_LincolnAve010_SE

ALTERATIONS:	PORCH	WINDOWS	TRIM	OVERALL
Material	None	Mod	None	Min
Configuration	None	Mod	None	Min

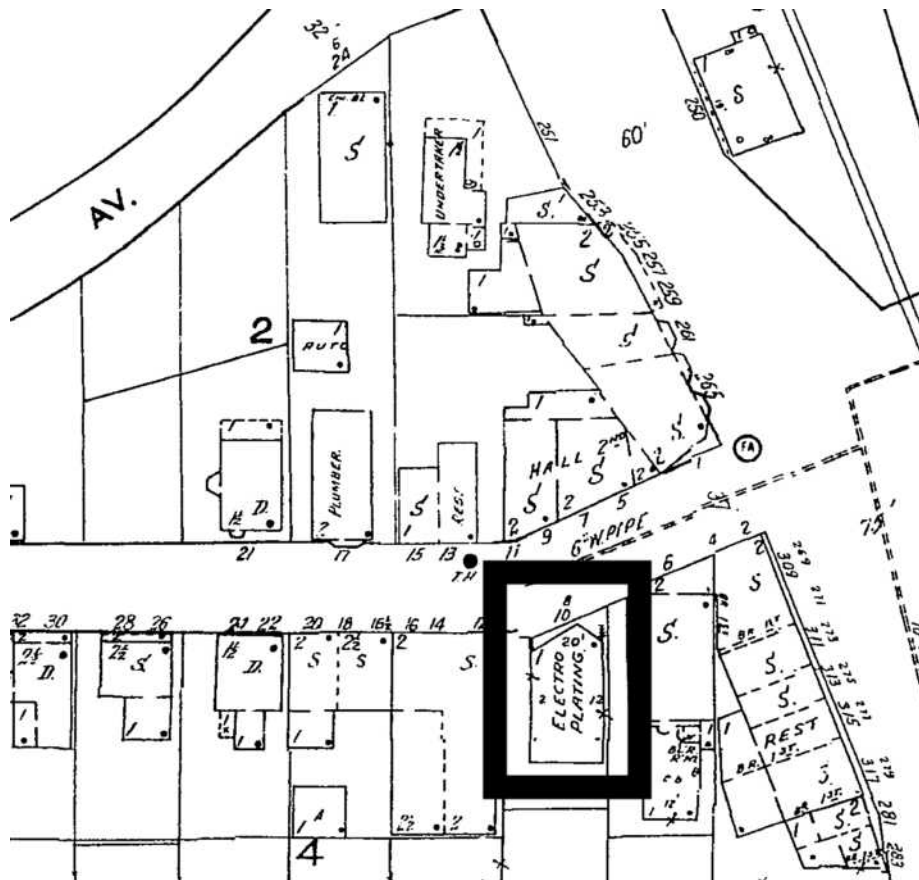
5. 1956 Sanborn shows that the building is now “Electro Plating.” Sanborn Map Company, Providence, Rhode Island (New York: Sanborn-Perris Map Co., 1956) Vol. 6, 56.

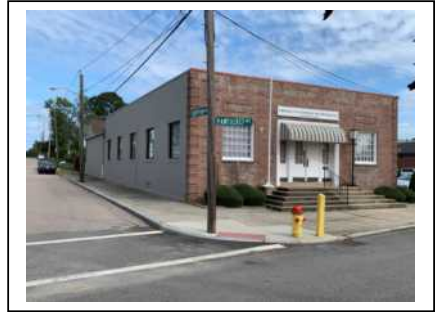
Photo ID EAPR_PawtucketAve3708_SE

FOUNDATION Concrete OTHER _____

WINDOWS (1) Six by five fixed sash windows (2) Four by five fixed sash aluminum window

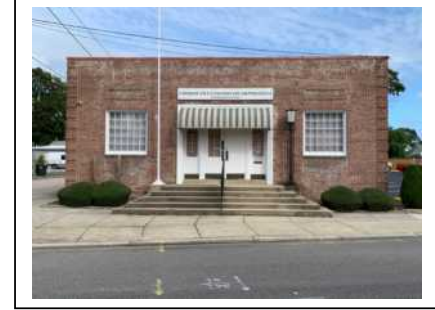
Photo ID EAPR_PawtucketAve3708_E

ALTERATIONS:	PORCH	WINDOWS	TRIM	OVERALL
Material	None	Mod	None	Min
Configuration	None	Min	None	Min

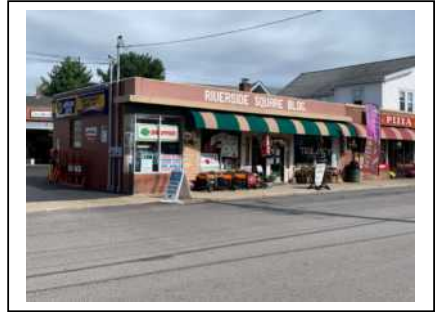
Photo ID EAPR_PawtucketAve3734_SE

FOUNDATION Not Visible OTHER _____

WINDOWS (1) Two-light fixed sash aluminum storefront windows (2) One-light fixed sash aluminum storefront window

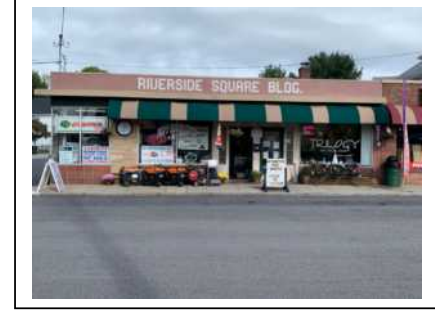
Photo ID EAPR_PawtucketAve3734_E

ALTERATIONS:	PORCH	WINDOWS	TRIM	OVERALL
Material	N/A	Min	Mod	Mod
Configuration	N/A	Min	Min	Min

3734 Pawtucket Avenue was built in the 1950s; a modern commercial building and replaced two smaller historic wood-frame buildings. The modest, single-story building of concrete block and brick, with Formstone trim, has housed a few businesses since its construction. The building is an interesting example of a modern building that still adheres to a historic mode of sidewalk fronting commercial space. The building also corresponds to the period of latest historic development in Riverside Square during the mid-twentieth century. The building, Other examples from this period are the similarly-styled addition to the then Babcock's Dry Goods Store, now Rhodes Pizza, adjacent to the building and the Dari-Bee ice cream stand. This period of development in Riverside Square, however, lacks a connection to any significant pattern of events in Riverside that would qualify it under Criterion A. There were no significant shifts in the development or living patterns that differentiate the square from any other community during this period, as development largely began to shift outside of Riverside Square. There is also no person associated with the property that would qualify the property for inclusion of Criterion B. The design of the building is mostly functional, likely not eligible for inclusion under Criterion C.

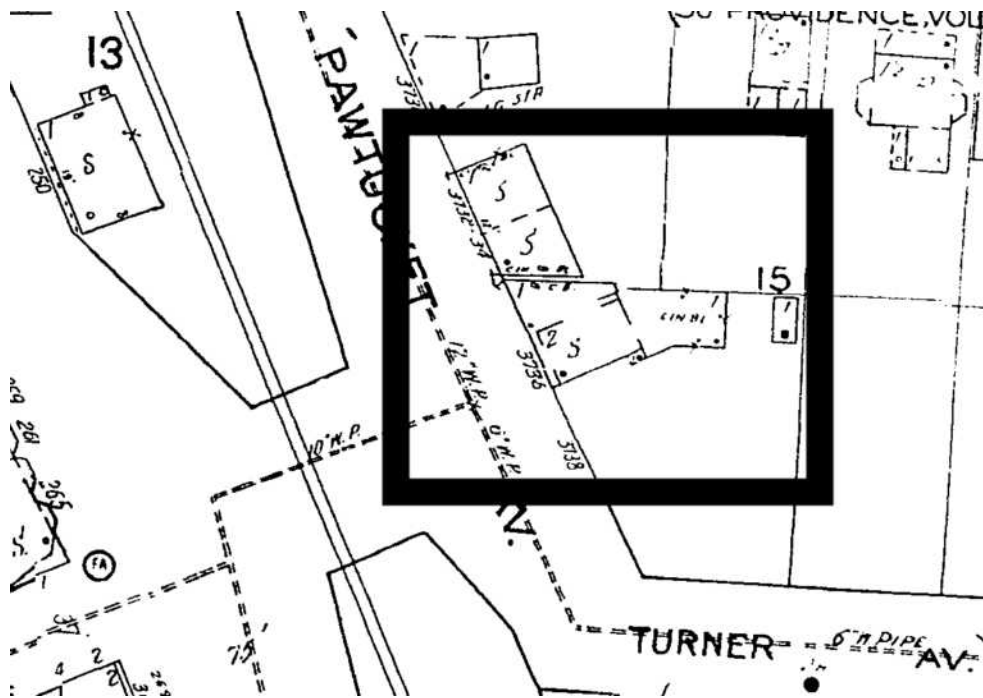
5. 1956 Sanborn now shows that the two small wood-frame shops are replaced with abutting one-story cinderblock shops that meet the Rhodes Pizza building at the property line. This is likely to be the Riverside Square Building. Sanborn Map Company, Providence, Rhode Island (New York: Sanborn-Perris Map Co., 1956) Vol. 6, 56.

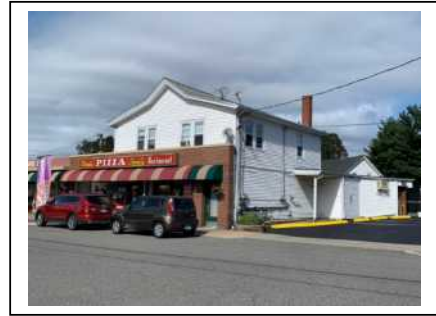
Photo ID EAPR PawtucketAve3736 NE

FOUNDATION Not Visible OTHER _____

WINDOWS (1) Single light fixed-sash aluminum storefront windows (2) Six-over-one double hung vinyl windows

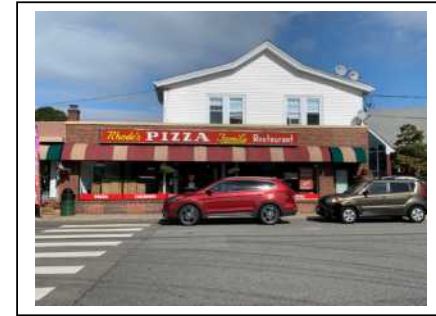
Photo ID EAPR PawtucketAve3736 E

ALTERATIONS:	PORCH	WINDOWS	TRIM	OVERALL
Material	N/A	Maj	Maj	Maj
Configuration	N/A	Maj	Maj	Maj

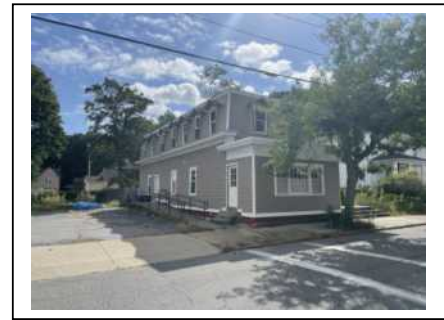
Photo ID EAPR TurnerAve009 SW

FOUNDATION Brick OTHER Asphalt shingle (lower roof)

WINDOWS Vinyl/Metal double-hung (1 over 1 and 6 over 6), three part divided glass window

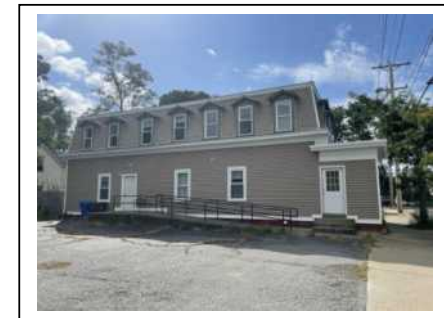
Photo ID EAPR TurnerAve009 W

ALTERATIONS:	PORCH				WINDOWS				TRIM				OVERALL			
Material	Maj	Mod	Min	None	Maj	Mod	Min	None	Maj	Mod	Min	None	Maj	Mod	Min	None
Configuration	Maj	Mod	Min	None	Maj	Mod	Min	None	Maj	Mod	Min	None	Maj	Mod	Min	None

While the current form of the building at 9 Turner Avenue has its original footprint, the massing, materials, and general historic integrity of the old fire station have been completely lost over time. The building no longer has the garage or bell tower used by the fire department which is certainly the largest loss of massing in the building's history, removing the feature used by the fire department. 9 Turner Avenue has also been through a series of materials and paint jobs, but in the past few years, the wood siding was completely replaced with gray/beige vinyl, completely removing the historic integrity of the building. While the building at 9 Turner Avenue has a long history, serving as the pre-automobile fire department in Riverside for almost thirty years, the historical character and integrity of the building have been lost, disqualifying the building for National Register eligibility.

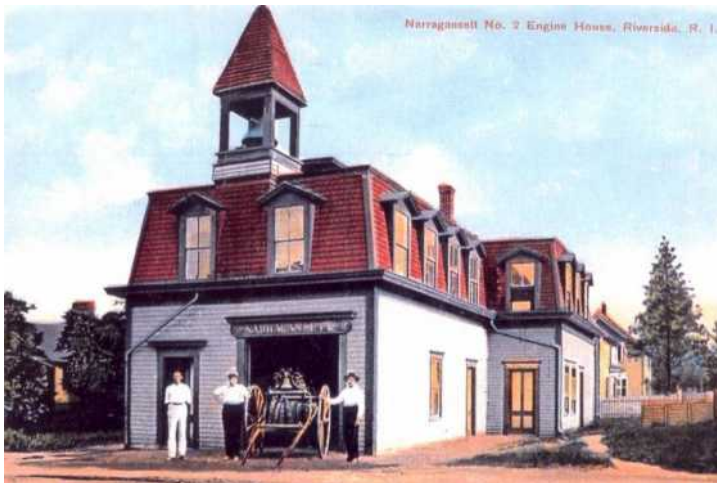
This artwork shows 9 Turner Avenue in its first form as the Narragansett Number 2 Engine House. The work shows the dramatic change in the building's architecture after it became mixed-use. At this time, the building had a bell tower, a stone chimney, a garage where the entrance/business is now, and red and white painted wood cladding. Source: Scanned from the East Providence City Planning Department.

The building at 9 Turner Avenue (formerly 31 Turner) was originally constructed by the Town of East Providence in 1880, to be the home of the Narragansett Engine Company No. 2, the fire department in Riverside at the time, as well as the police (East Providence Tax Assessor). The town bought the parcel in 1879 from one William P. Allen who bought the parcel in 1872 from one John A. Adams (EP Land Records, 4/394, 16/103). The Narragansett Engine Company itself was formed in 1802 making this building the second used by this branch of the department (buildingsofnewengland). The station was the first built in Riverside as the village's population grew and entered its resort era (Remick). After 28 years of successfully operating as the Riverside fire station, the department moved to a new building at 329 Bullocks Point Avenue (East Providence City Directory 1910). After the fire department left 9 Turner Avenue, the town sold the parcel and building to Francis G. Merewether and James J. Dunn who ran their contracting business from the former fire station (East Providence City Directory 1910). The duo specialized in plumbing and heating, as well as metalwork such as copper, tin, and sheet iron work which can be seen in this town directory advertisement from 1910. The two operated the business together for twenty years until Francis and his wife Margaret sold their ownership of the parcel to James in 1930 (EP Land Records, 111/210). The first floor was renovated to be a storefront at some point after the contracting partnership ended, removing the garage and bell tower used originally by the fire department. James owned the building until his passing in 1952 and the building was passed down to his son John P. Dunn (EP Land Records, 151/26). John kept the property until 1963, renting the upstairs apartment and renting to small businesses including Bob's Barbershop and a senior help center (East Providence City Directory 1974, 1980) In 1963 John sold the parcel to the church across the street, St. Mark's Episcopal (EP Land Records, 226/583). The church used the building for parish offices which can be seen in the 1967 East Providence directory. The church used the building for office space until 1985 when they sold the building to Marc and William Daquila, who started a chiropractor business on the first floor of the building (East Providence City Directory 1985-6). Along with the substantial physical changes earlier, at some point, the building was also fitted with wood shingle siding and the green and red paint job. The Daquila's chiropractic office was the longest-lasting business to exist in 9 Turner Avenue, even being sold to the next generation of the family, James P. Daquila in 1998 (EP Land Records, 1362/0335). James ran the office until very recently, replacing the entire exterior of the building with new, primarily vinyl materials and painting it beige and white, removing a significant amount of the building's historical character. After the renovations, James Daquila sold the building to Ting and Ben Chan who have not used the building for a business and it currently sits vacant (EP Land Records, 4312/56).

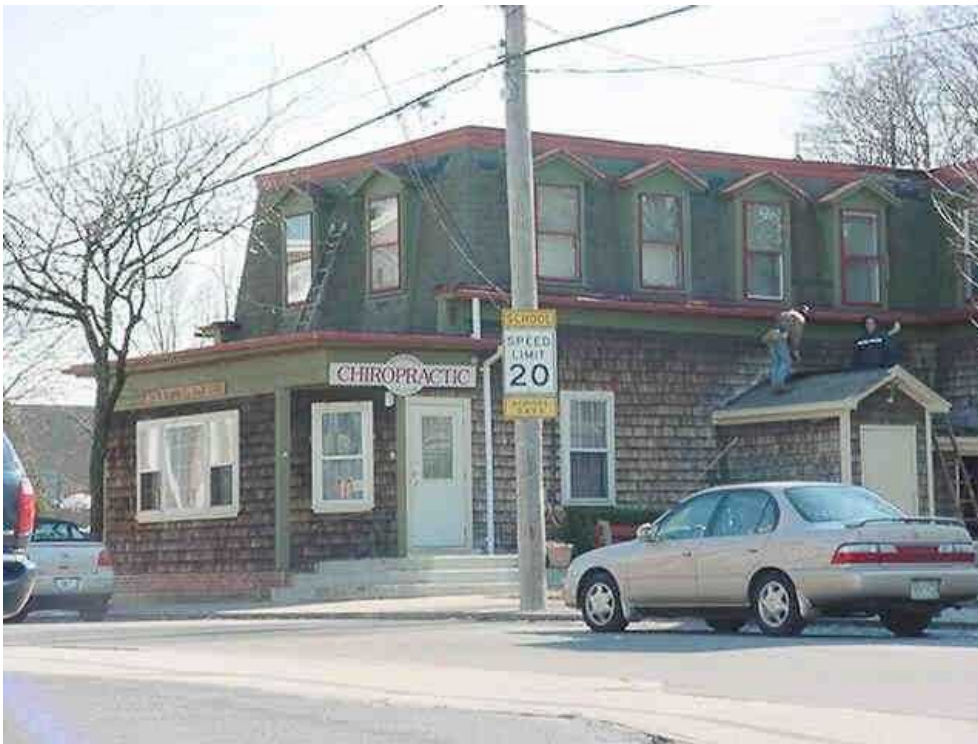
Shows the building before its vinyl renovation with its wood shingle first story and green and red paint style. Shows the first-floor chiropractic business that was previously in the building and a small shed addition. The general form of the building did not change during the cladding switch. Source: East Providence Tax Assessor database.

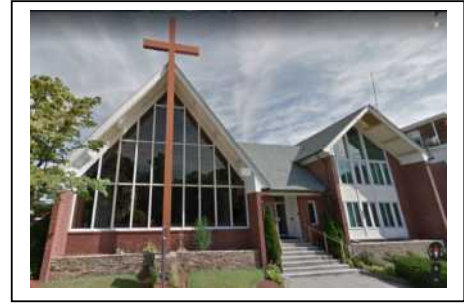
Photo ID EARP TurnerAve10 NE

FOUNDATION Stone/Concrete OTHER _____

WINDOWS Casement, fixed

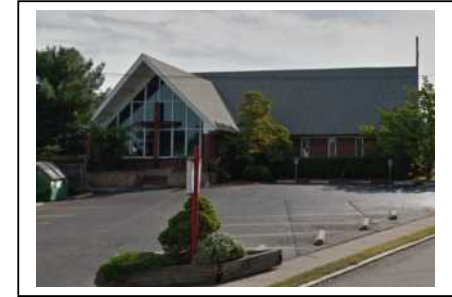
Photo ID EARP TurnerAve10 W

ALTERATIONS:	PORCH				WINDOWS				TRIM				OVERALL			
Material	Maj	Mod	Min	(None)	Maj	Mod	Min	(None)	Maj	Mod	Min	(None)	Maj	Mod	Min	(None)
Configuration	Maj	Mod	Min	(None)	Maj	Mod	Min	(None)	Maj	Mod	Min	(None)	Maj	Mod	Min	(None)

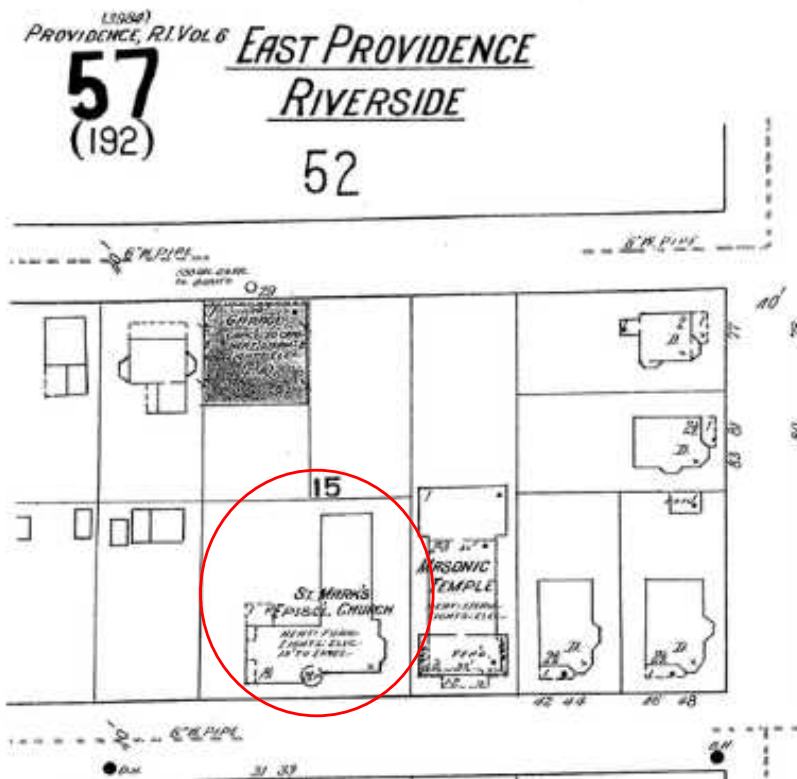
Figure 3: 1921 Sanborn map show highlighting the St. Mark’s Episcopal Church and its original construction that dates back to 1885. Source: *Providence, 1920-1921 Vol. 6, 1921*. ProQuest, Digital Sanborn Maps, 1867-1970. Pg. 57.

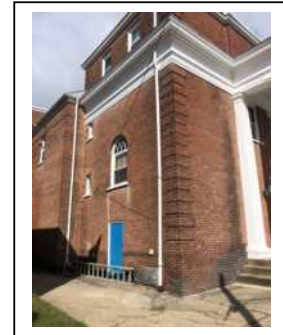
Photo ID EARP TurnerAve18 NE

ROOF Rubber WALL Brick

FOUNDATION Concrete OTHER _____

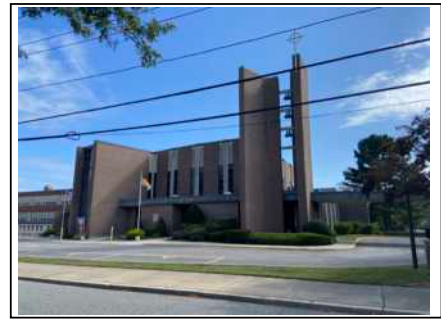
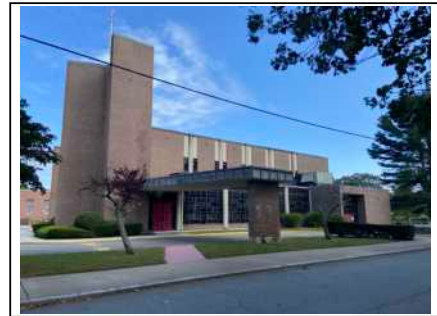
Photo ID EAPR_TurnerAve_50

WINDOWS Aluminum frames, fixed stained or lead windows and/or metal framing

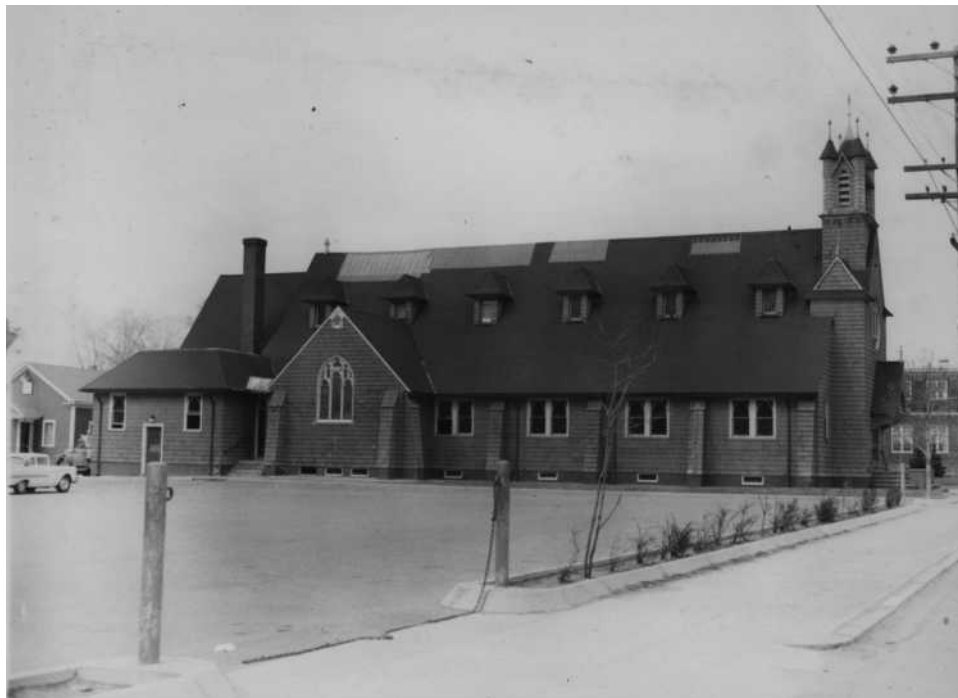
Figure 4: Photo of Saint Brendan's Church after the addition was added, taken after 1932

hardwood on a solid brick, and stone foundation (see Figure 3).⁹ When the new church opened, the number of Catholics living in the neighborhood had increased just at the right time for this expansion.¹⁷ In 1909, the mission was able to be established as a parish. Bishop Harkins established St. Brendan Mission as a parish on April 29, 1909.¹⁸ The first pastor was Father Joseph E. Hughes, the previous assistant pastor of the Assumption Church in Providence.¹⁹ In 1913, Father Hughes began to purchase the surrounding parcels around the church, and in 1920 sold the old chapel on Sprague Avenue, which stands today as a day-care center.²⁰ After Father Hughes passed away, Father John A. Toohey took over the church. The growing number of Catholics in the area increased. The newly built church needed more space to hold Mass for the increased number of Catholics. In 1932, an addition was added to the church, construction was done by William Noonan. The additions were on the rear and side of the church, and included flexible space to hold events, and expanded seating. But the main reason for the addition was to hold more residents for Mass. The enlarged church was rededicated on May 17, 1931, by Bishop William A. Hickey (see Figure 4).

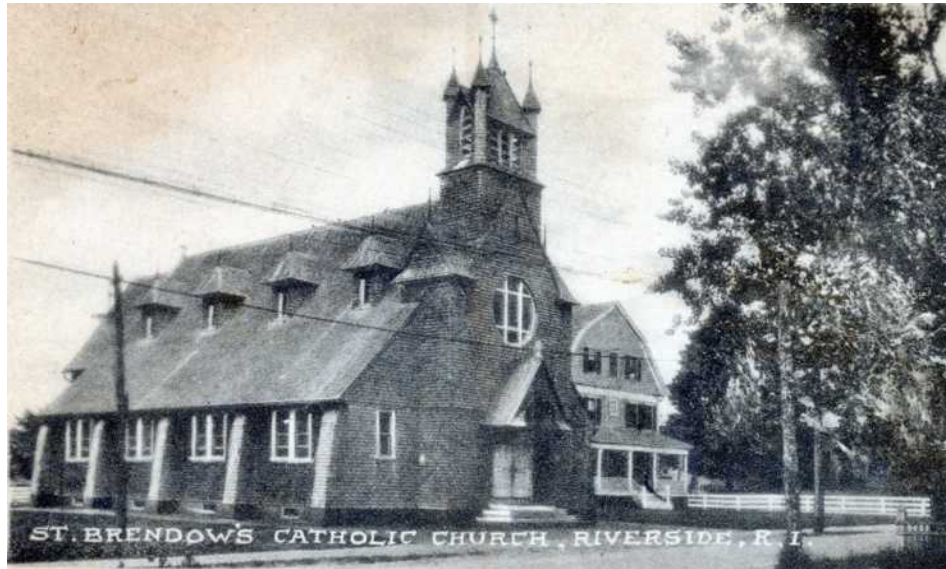
Figure 4: Postcard of St. Brendan’s Church with the renovated cottage to the side, date to be around 1920
 Source: Remick, Bruce. “St. Brendans Church with the rectory in the background that I had never seen before, circa 1920” Facebook, May 4, 2018.
<https://www.facebook.com/photo/?fbid=10156289120617246&set=gm.1743570782365235>

As the parish grew, in 1932 Father Toohey purchased the lot adjacent to the parish's property.¹⁰ This property had a cottage on it, which was a dwelling before but was renovated to become a Social Hall (see Figure 4). After years of wanting to open a parish school, it was finally made possible when the church leased the old Turner Avenue School from the town of East Providence to serve as the first Saint Brendan School, in 1943 (see Figure 5 and 6). The renovated cottage, also known as the Social Space Hall, became a temporary convent when the school opened. The parish acquired more land on Turner Avenue, preparing to build its school. When Father McCabe was replaced by Rev. William Tierney, raised the funds to build a new school. In May of 1955, construction for the school began, also a new convent across the street from the school was planned to be built, on 70 Turner Avenue. The school opened in 1956, and the new convent was finished in 1955.¹¹ In July of 1957, a fire broke out in the church. As the firefighters were fighting the fire, Lt. Robert McPherson went to the church's basement to make sure nobody was trapped, and he ended up getting trapped and dying as a result.¹² With the church building being demolished, the newly built school's large gymnasium became the parish for the church. All of the non-damaged furniture, and items that were not destroyed, transferred to the school gymnasium next door (see Figure 7).¹³ According to the aerial photograph, the parish had built clubhouses behind the Social Hall to gain some new spaces.
